T-001 Inspection Limits and Repair

1ST STAGE TURBINE NOZZLE

Engine Application(s):	250-C20, C20B, C20F, C20J, C20S, C20W.																					
Subject:	Inspection and Rework Procedure for the Un-coated A23038218 & E23038218 1 st Stage Turbine Nozzle Assembly.																					
Compliance:	<p>Any time the uncoated nozzle assembly is removed for overhaul. Refer to the appropriate Figures for Inspection and Rework Procedures.</p> <p>Fluorescent Penetrant Inspection per AMS 2647 or equivalent.</p> <p>After first airfoil restoration, re-identify by adding R1 after Part No. (e.g. E23038218R1,) and R2 after second airfoil restoration. Extex does not recommend more than two airfoil repairs to this part.</p> <p>Repaired Nozzle Assemblies shall meet dimensional requirements of Figure 2.</p> <p>Table 1: Acceptance, rework limits and procedures Figure 1: Inspection Figure 2: Dimensional Inspection</p>																					
Notes:	Replaces Service Letter T95-010 issued by Superior Turbine on July 26, 1995. Refer to OEM's published data for installation, engine operation and disassembly.																					
Revisions:

A23038218 & E23038218
1st Stage Nozzle Inspection

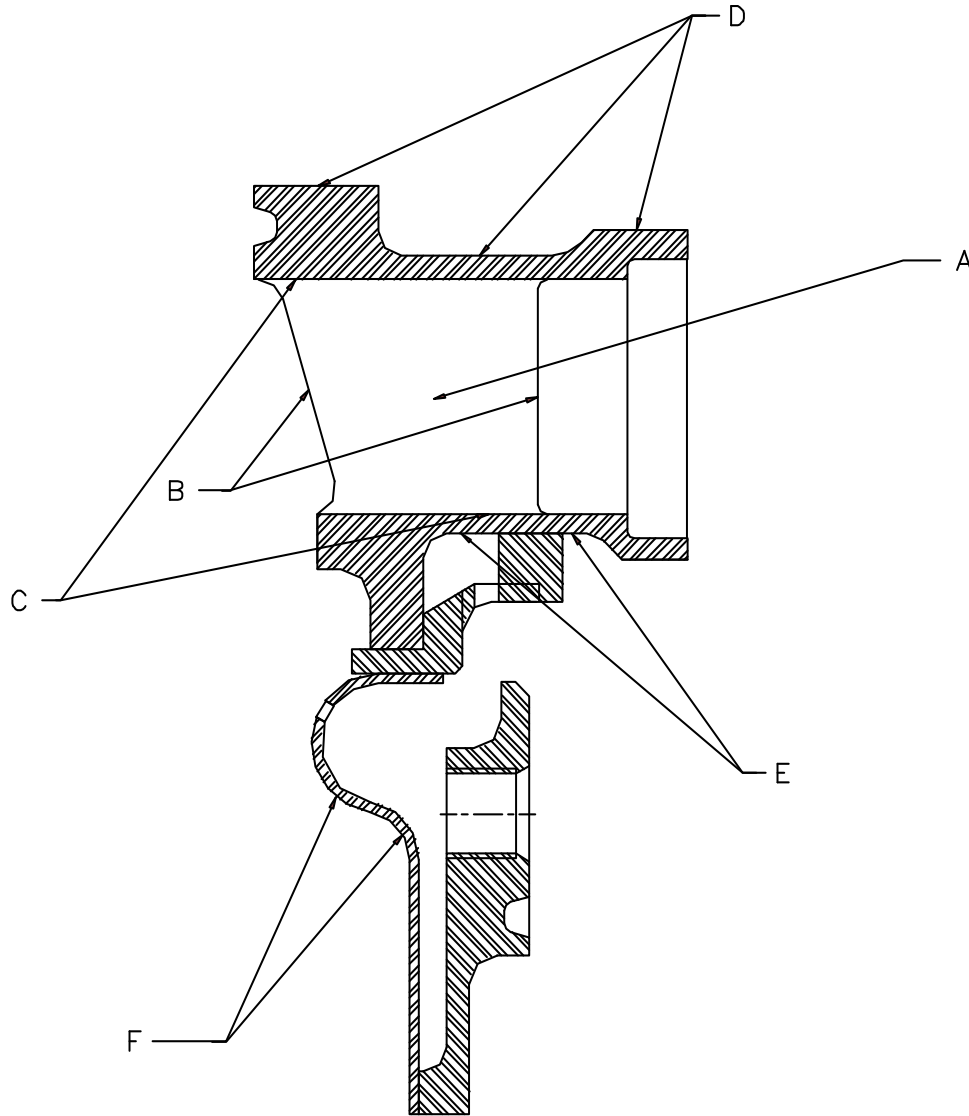
FIGURE 1

Code Letter	Location	Description of Condition
A	Vane Airfoil	Cracks
B	Vane Leading Edge Vane Trailing Edge	Nicked, Dented Nicked, Dented, Warped, Burned
C	Vane Fillet	Cracks
D	Outer Band	Cracks
E	Inner Band	Cracks
F	Diaphragm	Cracks

Location / Condition	Service and/or Repair Limits	Corrective Action
A - Airfoil Crack Indications	Leading Edge: 0.25 inch maximum is acceptable.* Trailing Edge: 0.25 inch maximum is acceptable.* *Acceptance is contingent upon the following: 1) No L.E. & T.E. cracks lie in the same plane. 2) Multiple cracks are separated by at least 0.25 inch. 3) Adjacent cracks do not converge.	Install new or serviceable Nozzle Assembly per approved procedure if Service Limit cannot be met. Airfoils may be repaired using FAA/DER approved procedure
B - Damaged Airfoils	L.E. & T.E. maximum material loss to a depth of 0.156 inch (4mm). Depth measured after blending.	Blend damaged surface(s) reference notes 3, 4, & 6. Replace Nozzle Assembly when service limit cannot be met Airfoils may be repaired using FAA/DER approved procedure.
B-Airfoil Negative Imperfections	Negative imperfections in the first 0.25" of the airfoil L.E. & T.E. are subject to the crack criteria. Negative imperfections between L.E. & T.E. are acceptable up to an area of: 1/16" dia. X 1/2 section thickness.	Airfoils may be repaired using FAA/DER approved procedure.

B-Airfoil Positive Imperfections	Positive imperfections in the first 0.25" of the airfoil L.E. & T.E. are to be no greater than 0.005", otherwise to 3/16" dia. X 0.010" height if smooth and adherent, and part line evidence to 0.015" height.	Airfoils may be repaired using FAA/DER approved procedure.
C - Vane Fillet Cracks	At Inner Band: 0.25 inch maximum from Leading or Trailing edge. At Outer Band: 0.25 inch maximum from Leading or Trailing edge. NOTE: Length specified is for cracks along the airfoil measured parallel to the adjacent band. Two or more cracks are acceptable provided they do not propagate towards another or could cause metal breakout.	Replace Nozzle Assembly when service limit cannot be met Airfoils may be repaired using FAA/DER approved procedure.

D - Outer Band Cracks	One crack extending 0.500 inch axially into the band or 0.625 inch (16mm) circumferentially between vanes and completely through wall.	Install new or serviceable Nozzle if Service Limit cannot be met. Repair using approved braze procedure. Repair using approved weld procedure when braze capability is exceeded. EFA to be between 3.30 and 3.31 after repair. Outer Bands may be repaired using FAA/DER approved procedure.
E - Inner Band Crack	One axial crack 0.190 inch maximum into band but not through diaphragm braze fillet.	Replace Nozzle Assembly when service limit cannot be met.
F - Diaphragm Crack	Cracks are not acceptable.	Install new or serviceable Nozzle Assembly.
