T-009 Inspection Limits and Repair

| Subject: | Inspection and Repair of Second Stage Turbine Nozzles |
| EEP Part Numbers: | A23031938, E23031938, A23031938-C, E23031938-C, 23031938AL, E6878426, E6878426-C |
| Reason: | To provide Supplemental Instruction for Continued Airworthiness (ICA) |

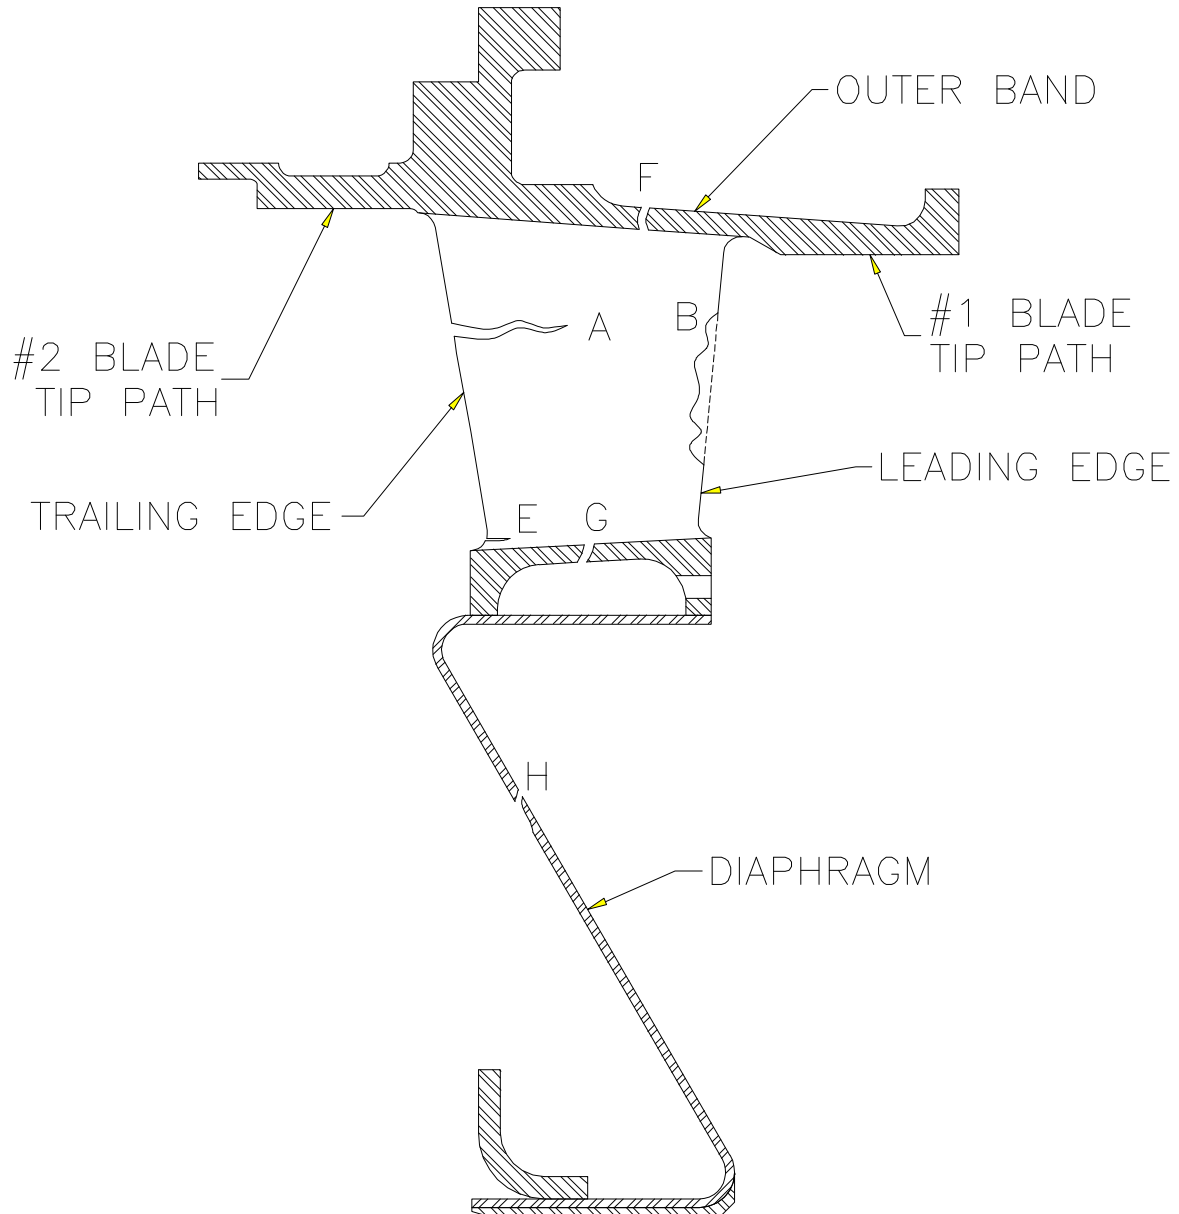
FIGURE 1

Instructions are provided to strip coating from gas path surfaces; weld repair of airfoil leading and trailing edges; braze repair of airfoil and fillet cracks; weld or braze repair of inner and outer band cracks, airflow adjustment; and replacement of diaphragm and support plate. Figure 1 depicts key features of the subject nozzles.

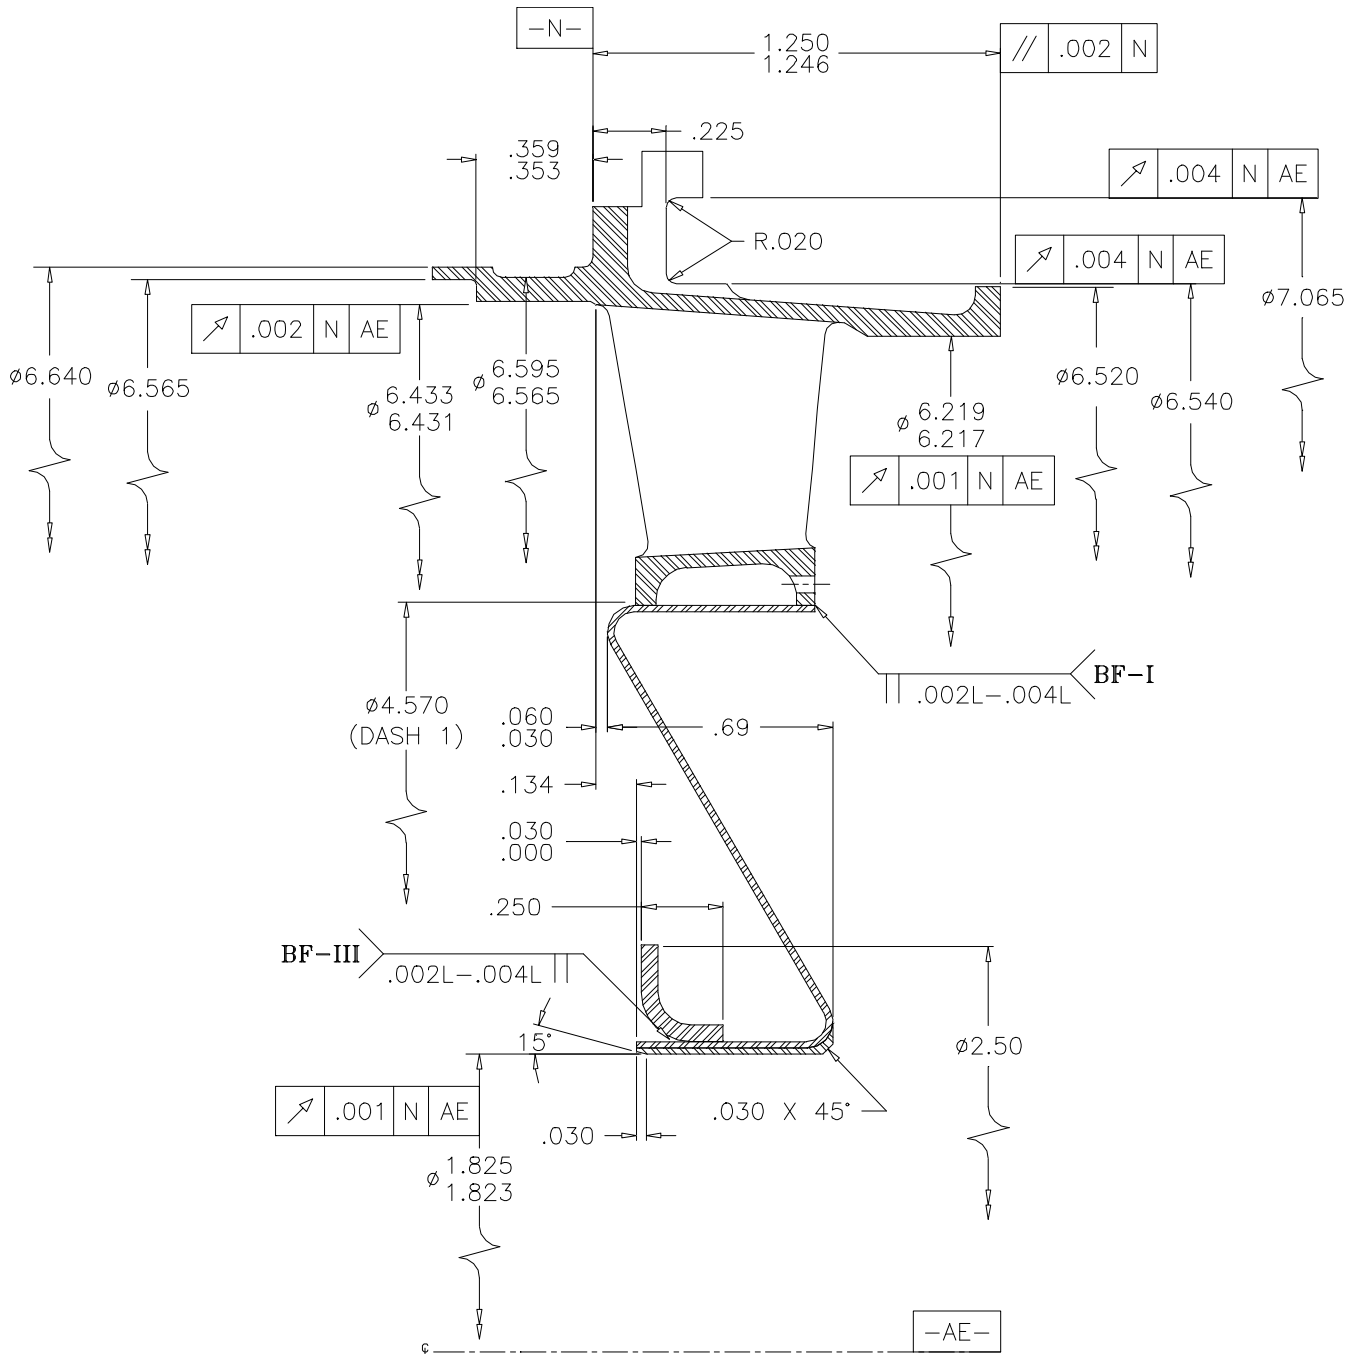
FIGURE 2: A23031938, E23031938, A23031938-C, E23031938-C & 23031938AL

| Location / Condition | Service Limits | Corrective Action |
|---|--|---|
| I - Inner Seal Bore Wear/Grooving | Polish to remove burrs and sharp edges. I.D.: 1.823 - 1.825 inch diameter. Depth of Grooves: 0.012 inch maximum. Concentricity: 0.003 inch maximum TIR. | Re-plate or metallize per attached procedures - See Figures 2 & 3. Minimum sheet metal wall thickness: 0.020 inch. Replace sheet metal if minimum wall thickness requirement is violated. |

part to prevent overspray of adjacent surfaces. Brush surface to be metallized with lacquer thinner or methyl ethyl ketone. Metallize per Nickel-Chromium-Boron Nitride Composite, Plasma Flame Deposition using METCO 301NS. Remove masking carefully and clean off overspray. Finish machine the Center Bore to 1.823-1.825 inches by single point turning leaving a thickness of 0.015-0.025 inch of Metco 301. After machining dimensionally inspect per Figure 2 or 3, as appropriate.

9.0 Installation of Diaphragm: Install a new or serviceable diaphragm by brazing with the two mounting surfaces of the inner band of the vane ring as shown in Figure 3. Be certain to prevent braze material from entering axial holes in the inner band of the vane ring. Location of the diaphragm relative to the vane ring is presented in Figures 2 & 3. Braze per AMS 2675 using AMS 4782 or AMS 4785 or AMS 4777 alloy.

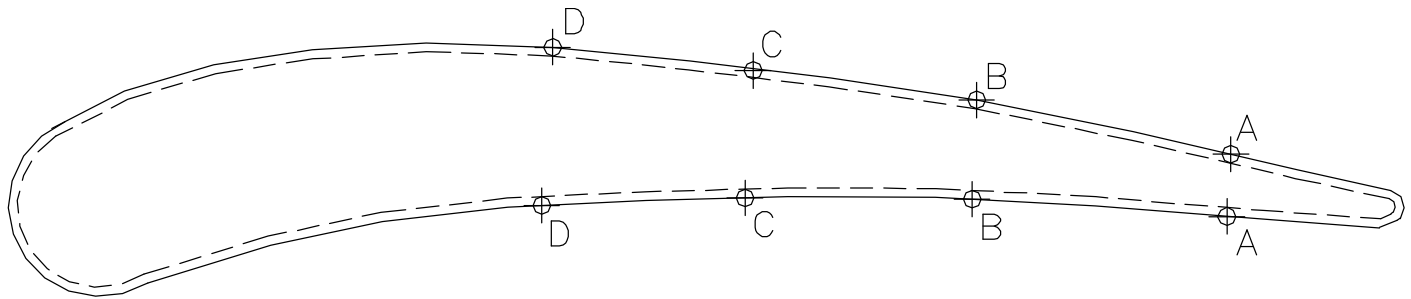
FIGURE 4

TYPICAL AIRFOIL CROSS-SECTION

EFA of repaired nozzles must be checked and modified if not within acceptable range. See Section 10. Repaired airfoils must meet minimum dimensions shown in Figure 4.

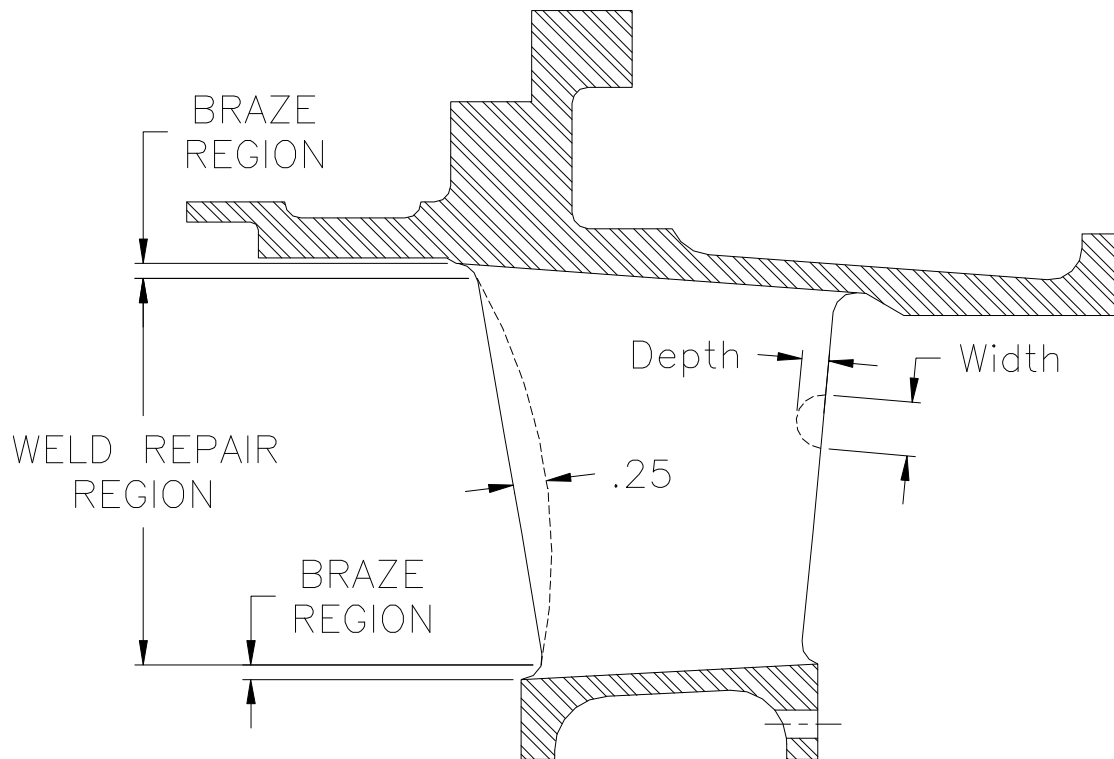
FIGURE 5

3.0 Weld Repair of Airfoils: Welding can be used to replace missing material at airfoil edges or it can be used to repair damage such as cracks. Blend areas to be welded with coated abrasives and/or carbide burr. Remove all sharp edges, cracks, and surface contamination; such as oxides (from engine service). Material removal should not exceed a depth of .250" from LE or TE of airfoil. Material removal should appear as a gradual arc with a width to depth ratio of 2:1, see Figure 5. Material removal and welding should not be attempted within .050 of fillet between airfoils and inner/outer bands. Fillet cracks should be repaired via furnace braze, see Section 5.

Just prior to welding, all surfaces to be welded should be retouched with a carbide burr. Preheat part to 700°F (371°C) before welding and maintain an inter-pass temperature of 700°F (371°C). Weld build-up as necessary via Gas Tungsten Arc (GTA) welding, also known as Tungsten Inert Gas (TIG) welding. It is recommended to use .030" to .045" diameter weld filler. Weld filler may be Inconel 625 or Inconel 738 (base alloy), see note below. Minimize heat input to avoid cracking.
