**T-011 Inspection Limits and Repair**

**Engine Application(s):** Allison 250-C20, C20B, C20F, C20J

**Spur Adapter Gearshaft and Spur Adapter Gearshaft Assembly  
Inspection and Rework Limits**

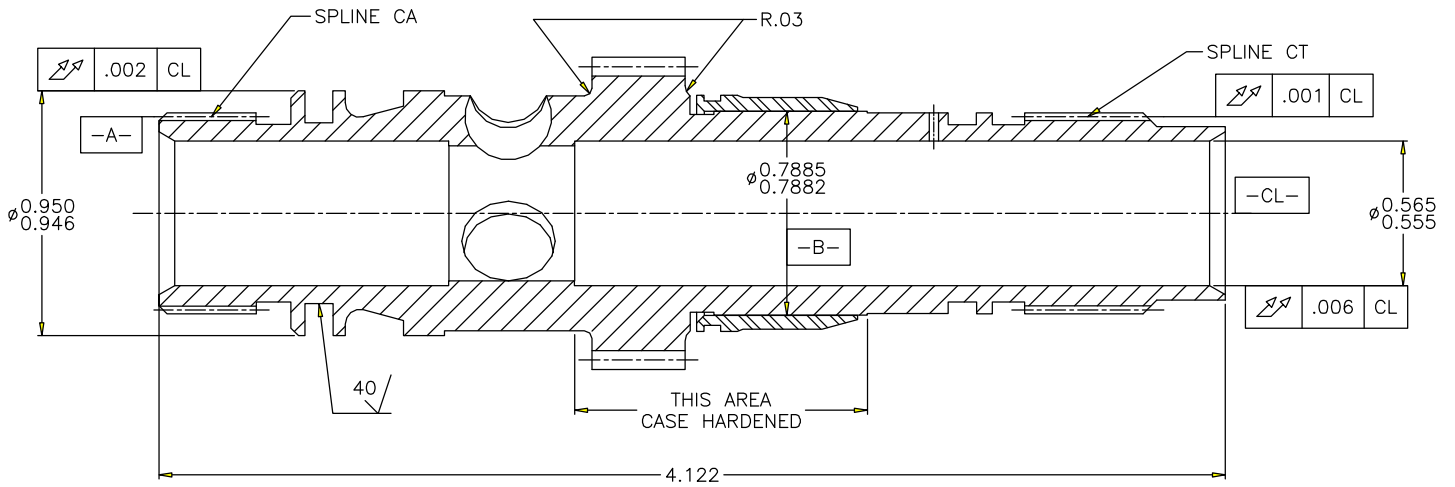
**FIGURE 1**

**A6899239/E6899239 Spur Adapter Gearshaft &  
 A23034784/E23034784 Assembly  
 Dimensional Inspection**

SPLINES CA AND CT HAVE 0.7500" PITCH DIAMETERS.  
 CENTERLINE -CL- IS DEFINED BY PD OF SPLINE CA AND DIAMETER -B-.  
 IF UNACCEPTABLE WEAR IS FOUND ON GEARSHAFT SPLINE CA, THEN  
 REPLACE COUPLING ADAPTER AND SPUR ADAPTER GEARSHAFT AS A SET.  
 DIMENSIONS ARE IN INCHES.  
 FINISHES ARE IN MICROINCHES.

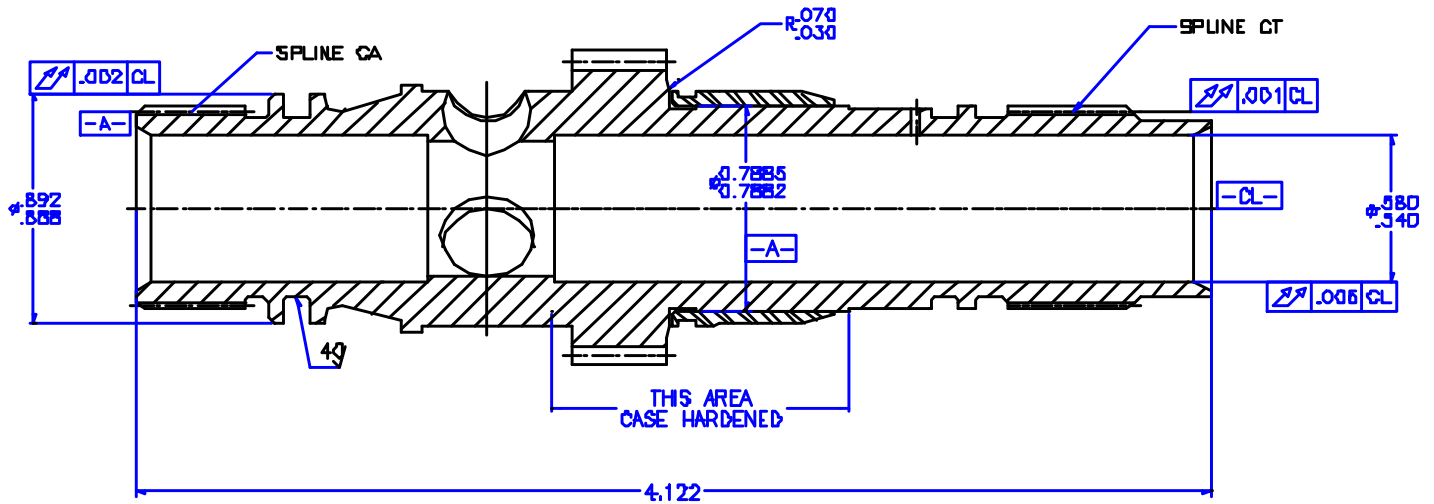
**FIGURE 2**

**A23031921/E23031921 Spur Adapter Gearshaft &  
A23031922/E23031922 Assembly  
Dimensional Inspection**

IF UNACCEPTABLE WEAR IS FOUND ON GEARSHAFT SPLINE CA, THEN  
REPLACE COUPLING ADAPTER AND SPUR ADAPTER GEARSHAFT AS A SET.
