## Coated Stellite 1<sup>st</sup> Stage Turbine Nozzle

**Engine Application(s):** 250-C20, C20B, C20F, C20J, C20S, C20W

**Subject:** Inspection and Rework Procedures for the Coated A23038218-C505 & E23038218-C505 1<sup>st</sup> Stage Turbine Nozzle Assembly.

**T-013 Inspection Limits and Repair**

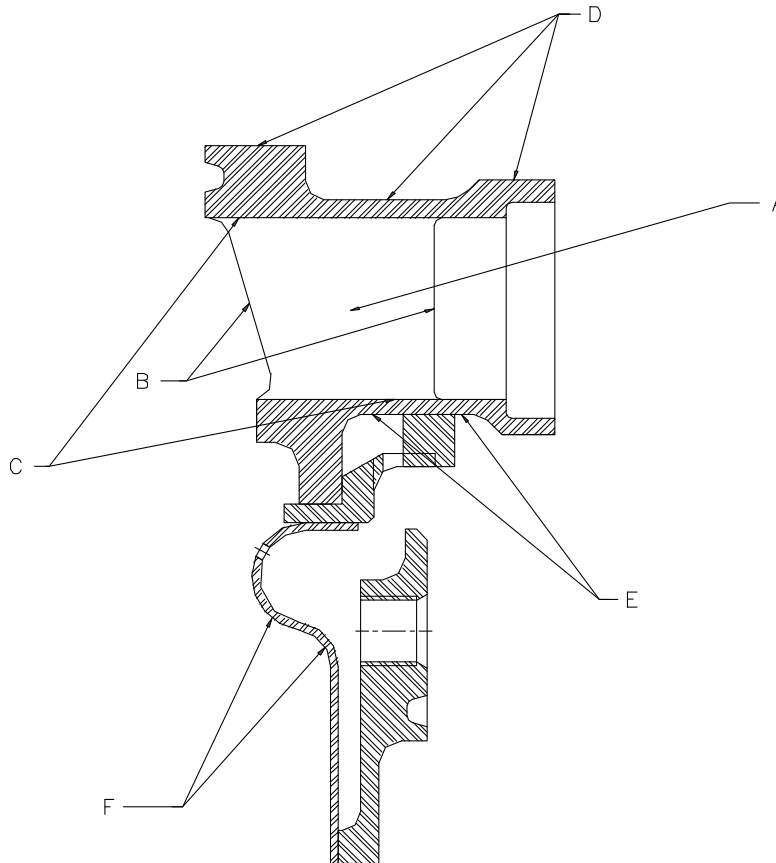
**FIGURE 1**

Code Letter	Location	Description of Condition
A	Vane Airfoil	Cracks
B	Vane Leading Edge Vane Trailing Edge	Nicked, Dented Nicked, Dented, Warped, Burned
C	Vane Fillet	Cracks
D	Outer Band	Cracks
E	Inner Band	Cracks
F	Diaphragm	Cracks

Condition	Service and/or Repair	Corrective Action
<b>Airfoil Crack Indications, Visual and FPI</b>	Leading Edge: 0.25 inch maximum is acceptable.* Trailing Edge: 0.25 inch maximum is acceptable.*  *Acceptance is contingent upon the following: 1) Two or more cracks cannot lie in the same plane. 2) Multiple cracks are separated by at least 0.25 inch. 3) Two or more cracks do not propagate towards another.	Install new or serviceable Nozzle or replace Vane Ring per approved procedure if Service Limit cannot be met.  Repair using approved braze procedure. Repair using approved weld procedure when braze capability is exceeded. EFA to be between 3.30 and 3.31 after repair. Airfoils may be repaired using FAA/DER approved procedure.
<b>Machined Surfaces, Visual Damage</b>	Machined Surface Damage is not acceptable after blending.  Damage greater than 0.12 inch dia and 0.010 depth cannot be repaired.	Blend damaged surface(s) with Arkansas stone or emery cloth.  Replace Nozzle Assembly when damage cannot be repaired.

<b>Damaged Airfoils**</b>	Leading Edge: 0.156 inch maximum after blending is acceptable provided the EFA is between 3.30 and 3.33. Trailing Edge: 0.156 inch maximum after blending is acceptable provided the EFA is between 3.30 and 3.33.	Install new or serviceable Nozzle or replace Vane Ring per approved procedure if Service Limit cannot be met. Blend airfoil to remove damage. <b>*** See Note on Page 4</b> Weld repair or replace vane ring when damage exceeds limits. Replace vane ring when service limit cannot be met. Airfoils may be repaired using FAA/DER approved procedure.
<b>Airfoil Fillet Crack Indications, Visual and FPI</b>	At Inner Band: 0.19 inch maximum from Leading or Trailing edge. At Outer Band: 0.19 inch maximum from Leading or Trailing edge. <b>NOTE:</b> Length specified is for cracks along the airfoil measured parallel to the adjacent band. Two or more cracks are acceptable provided they do not propagate towards another.	Install new or serviceable Nozzle or replace Vane Ring per approved procedure if Service Limit cannot be met. Repair using approved braze procedure. Repair using approved weld procedure when braze capability is exceeded. EFA to be between 3.30 and 3.31 after repair. Airfoils may be repaired using FAA/DER approved procedure.

Condition	Service and/or Repair Limits	Corrective Action
Inner & Outer Band Crack Indications, Visual and FPI	<b>Outer Band:</b> Axial: 0.38 inch maximum into band provided there are not cracks in line on the opposite edge. Circumferential: 0.50 inch maximum provided cracks are between vanes.	Install new or serviceable Nozzle or replace Vane Ring per approved procedure if Service Limit cannot be met. Repair using approved braze procedure. Repair using approved weld procedure when braze capability is exceeded. EFA to be between 3.30 and 3.31 after repair.
Inner & Outer Band Crack Indications, Visual and FPI (cont'd)	<b>Inner Band:</b> Axial: 0.19 inch maximum into band provided there are not cracks in line on the opposite edge. Circumferential: Circumferential cracks are not acceptable.	Install new or serviceable Nozzle or replace Vane Ring per approved procedure if Service Limit cannot be met. Repair using approved braze procedure. Repair using approved weld procedure when braze capability is exceeded. EFA to be between 3.30 and 3.31 after repair.

Diaphragm Cracking, Visual and FPI***	Cracks are not acceptable.	Install new or serviceable Nozzle or replace Diaphragm assembly per approved procedure.

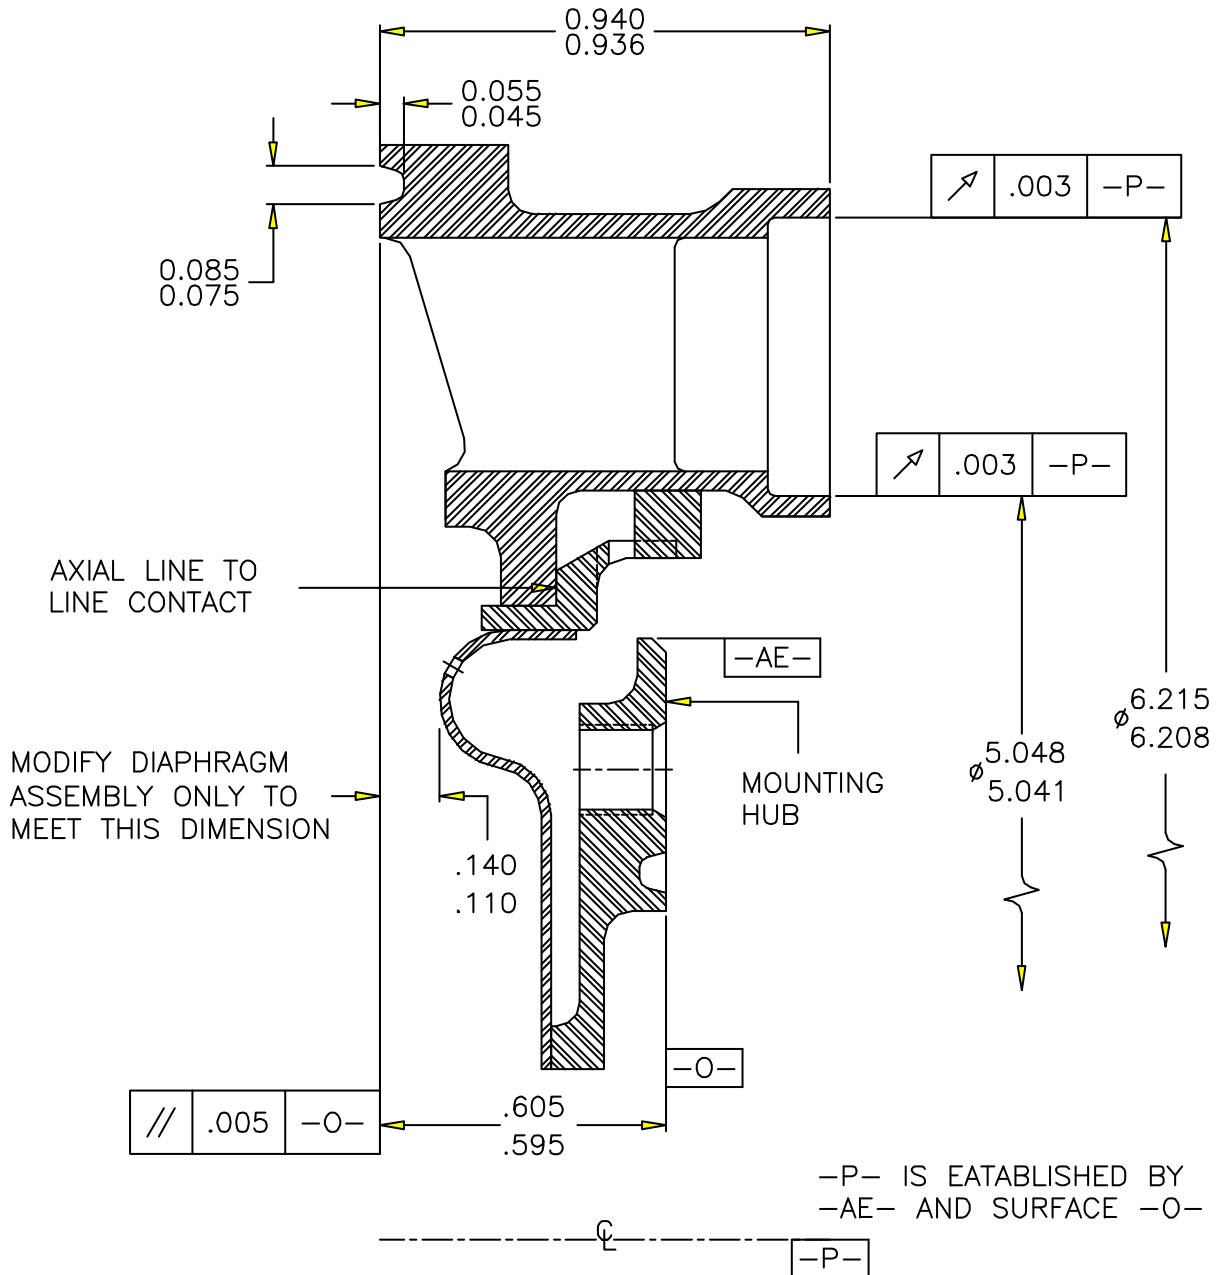
**FIGURE 2**

Repaired Nozzle Assemblies shall meet dimensional requirements of Figure 2.
