**T-014 Inspection Limits and Repair**

**Stationary Labyrinth Seal**

<b>Engine Application(s):</b>	250-B15G 250-B17F, B17F/1, B17F/2 250-C18, C18A, C18B, C18C 250-C20, C20B, C20F, C20J, C20S, C20W 250-C20R, C20R/1, C20R/2, C20R/4
<b>Subject:</b>	Inspection and Rework Procedure for the A6877736-1 & -2 & E6877736-1 & -2 Stationary Labyrinth Seal.
<b>Compliance:</b>	Any time the Stationary Labyrinth Seal is removed for overhaul. Refer to the Figures for Inspection and Rework Procedures.
<b>Notes:</b>	Replaces Service Letter T95-001 issued by Superior Turbine on April 1, 1997. Refer to OEM's published data for installation, engine operation and disassembly.
<b>Revisions:</b>	N/C Dated: 01/30/97 Initial release. A Dated: 12/02/97 Updated format. B Dated: 01/26/01 Updated format. C Dated: 09/09/09 Updated EXTEX to TIMKEN. D Dated: 2/02/16 Updated Timken to EXTEX Engineered Products.

A6877736-1 & -2 & E6877736-1 & -2  
**Stationary Labyrinth Seal**  
**Inspection and Rework Limits**

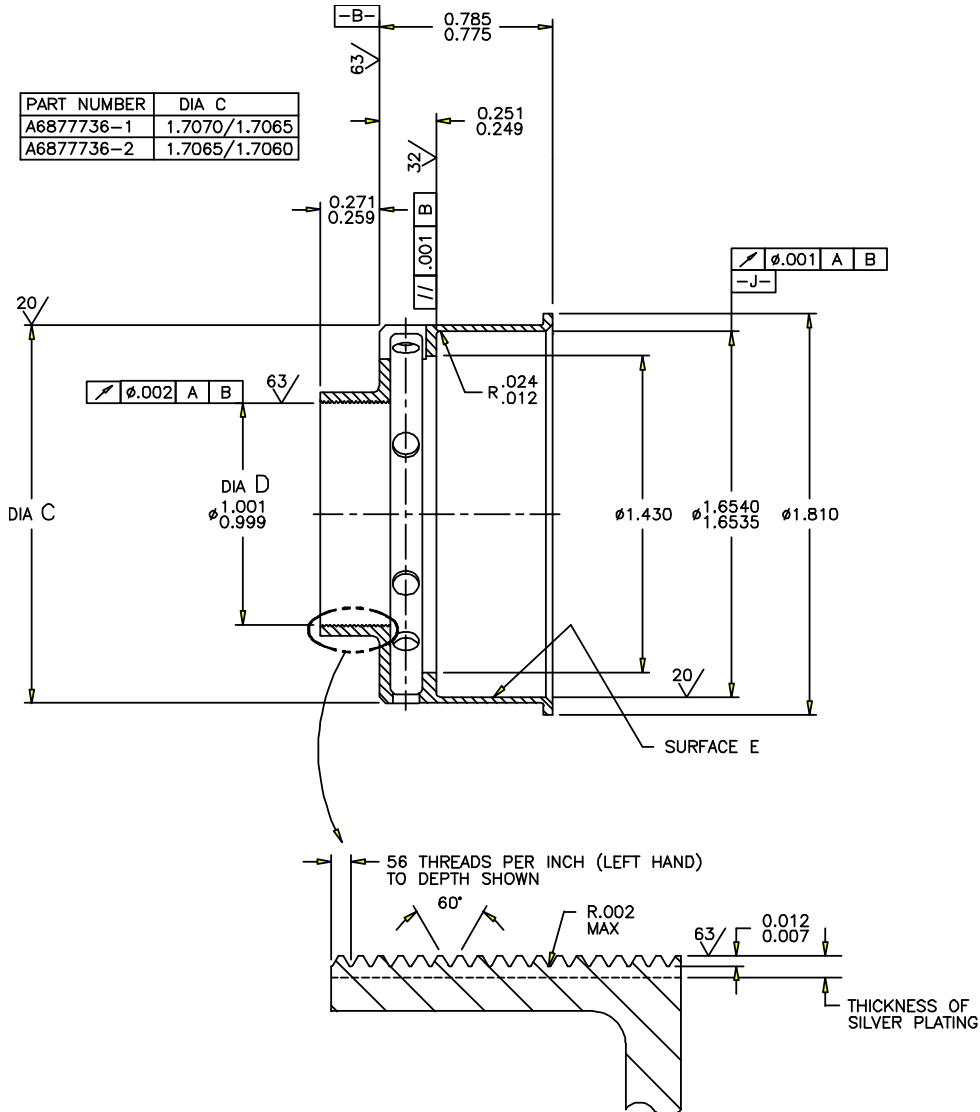
**FIGURE 1**

**A6877736-1 & -2 & E6877736-1 & -2  
Labyrinth Seal Inspection and Repair**

- NICKEL PLATE SURFACE E 0.0001-0.0003 IN. THICK AND BAKE AT
- 750° +/- 10°F FOR ONE HALF HOUR. OTHER SURFACES OPTIONAL.
- SILVER PLATE DIA. D 0.015-0.025 IN. THICK AFTER MACHINING.
- ALL DIM. TO BE MET AFTER PLATING.
- FINISH ALL OVER 125 MICRO-INCHES UNLESS OTHERWISE SPECIFIED BEFORE PLATING.
