**T-016 Service Bulletin**

<b>Subject:</b>	Inspection and Repair of Power Turbine Inner Shafts
<b>EXTEX Engineered Products Part Numbers:</b>	A23037403, E23037403, E23071309, 23071309AL
<b>Installations:</b>	Rolls-Royce (250-B17, B17B, B17C, B17D, B17E, B17F, B17F/1, B17F/2; 250-C20, C20B, C20C, C20F, C20J, C20S, C20W, C20R, C20R/1, C20R/2, C20R/4)
<b>Revision History:</b>	<p>NC – Dated 1/30/97 Original Release.  A – Dated 12/02/97 Updated format.  B – Dated 06/11/98 Added Repair instructions. Updated format.  C – Dated 02/01/01 Added P/N E23071309.  D – Dated 01/13/02 Updated format and revised Inspection procedures.  E – Dated 09/09/09 Updated EXTEX to TIMKEN.  F – Dated 11/27/12 Added P/N 23071309AL and updated eligible installations. Updated to current format.  G – Dated 02/05/13 Added Table entry on buttress thread length and added associated Figure as “Figure 1”. Former “Figure 1” now “Figure 2”. Updated Timken Logo and incorporated warning graphics on page 4. Removed references to other figures, corrected font in Figure 2.  H – Dated 2/02/16 Updated Timken to EXTEX Engineered Products.</p>

<b>Reason:</b>	To provide Instruction for Continued Airworthiness (ICA)
<b>Descripti

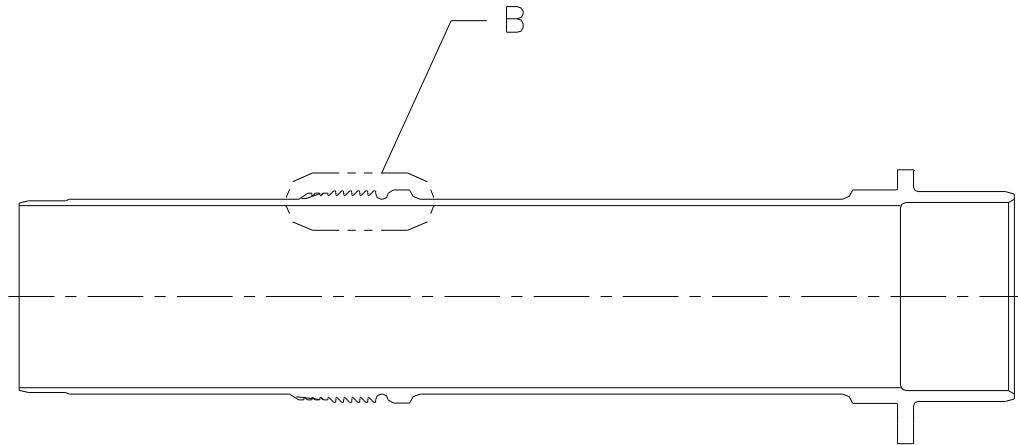
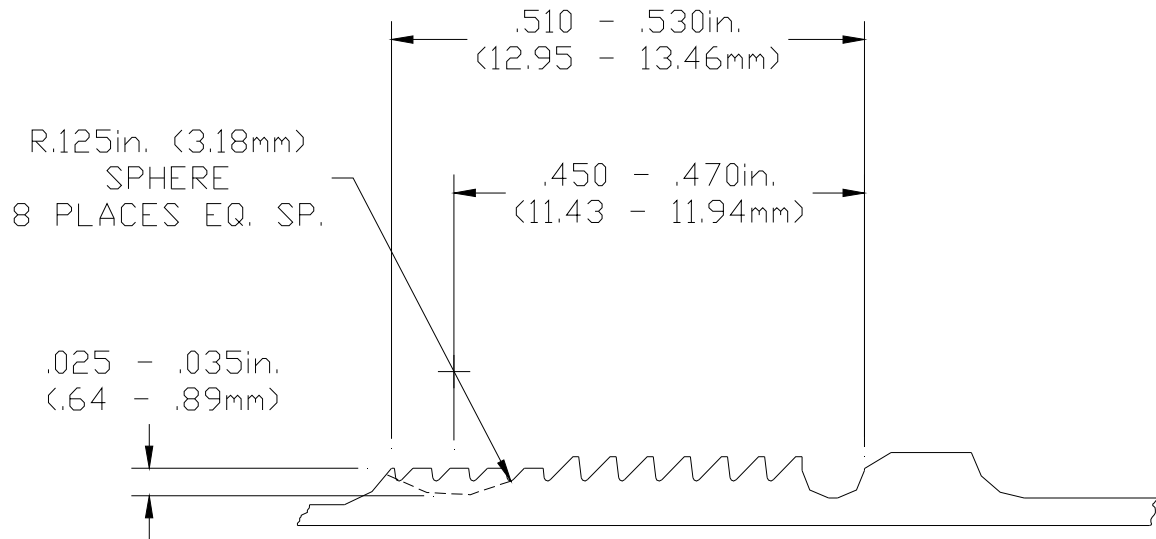
**FIGURE 1**

<b>Pitting on the Bearing Race</b>	Max pit size 0.010". Max cluster of pits (3 or more, including open slag inclusions) within an area .25" in dia, no pit larger than .006" detectable with R.030" scribe.	No permissible repair.	Replace.
<b>Corrosion Pitting on Areas Other than Bearing Race</b>	Min wall thickness of .030 after blending	No repair limit.	Blend pitted area removing minimum material. <b>OR</b> Replace Shaft.
<b>Buttress Thread Length for Nut Locking Feature</b>	Refer to Figure 1.	No permissible repair.	Replace.

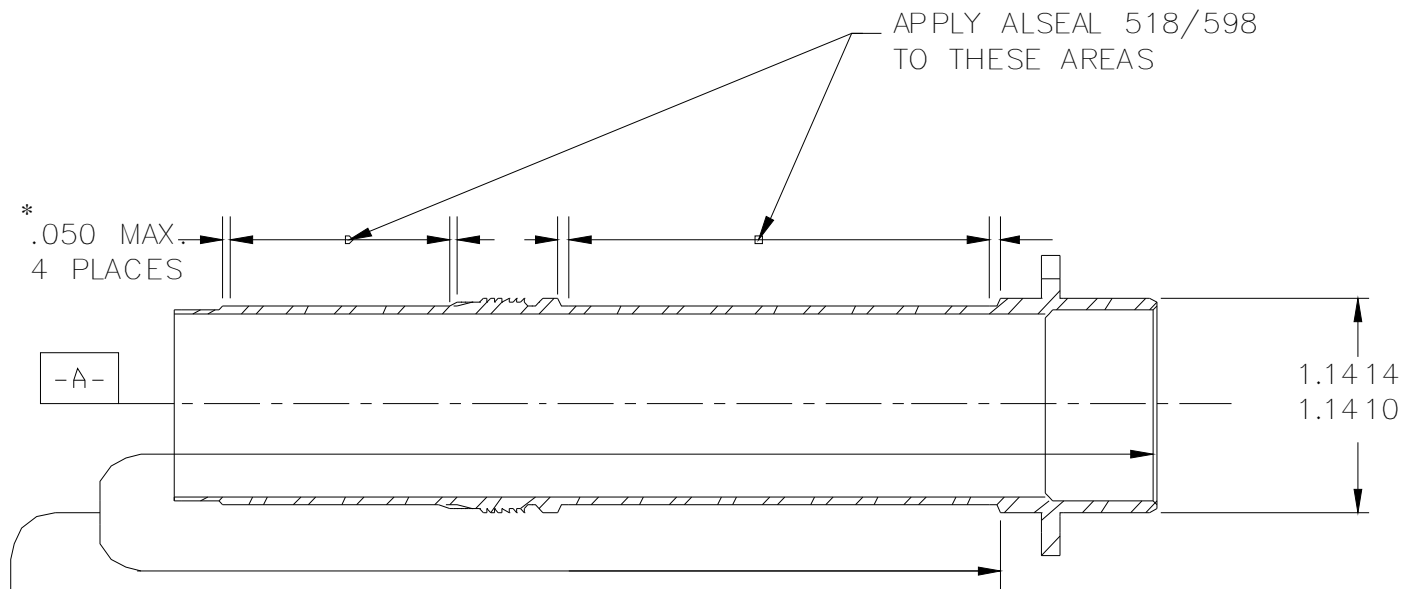
**FIGURE 2**

\*.050 MAX APPLIES TO A23037403 & E23037403 ONLY.  
E23071309 AND 23071309AL MUST BE COVERED COMPLETELY TO SHOULDER.

AFTER STRIPPING AND BLENDING, ELECTROLESS NICKEL PLATE AREA SHOWN PER AMS 2405, THICKNESS .0005-.0007 BAKE THREE HOURS AT  $350^{\circ} \pm 15^{\circ} \text{F}$ .

- 1.0 Apply electroless nickel plating, to the areas shown in Figure 2, to the shafts that have passed the inspection criteria and are considered serviceable.
- 2.0 Apply Aseal 518/598 coating over the electroless nickel plating in areas shown in Figure 2 except for:
- a. Base coat shall be 0.002-0.004 inch thick (two layers 0.001-0.002 in).
  - b. Prior to application of top coat, burnish base coat using 00 grade steel wool or lightly aluminum oxide grit blast until a reading of 0.25-3.0 ohms is obtained when the probes of an ohmmeter are lightly held 1.00 inch apart.
  - c. No requirements are established for coating thickness for deep recesses in which controlled coating thickness cannot be obtained under normal application techniques.
