**T-019 Inspection Limits and Repair**

**Bearing Retaining Plate**

**A6895005 & E6895005 Bearing Retaining Plates  
Inspection and Rework Limits**

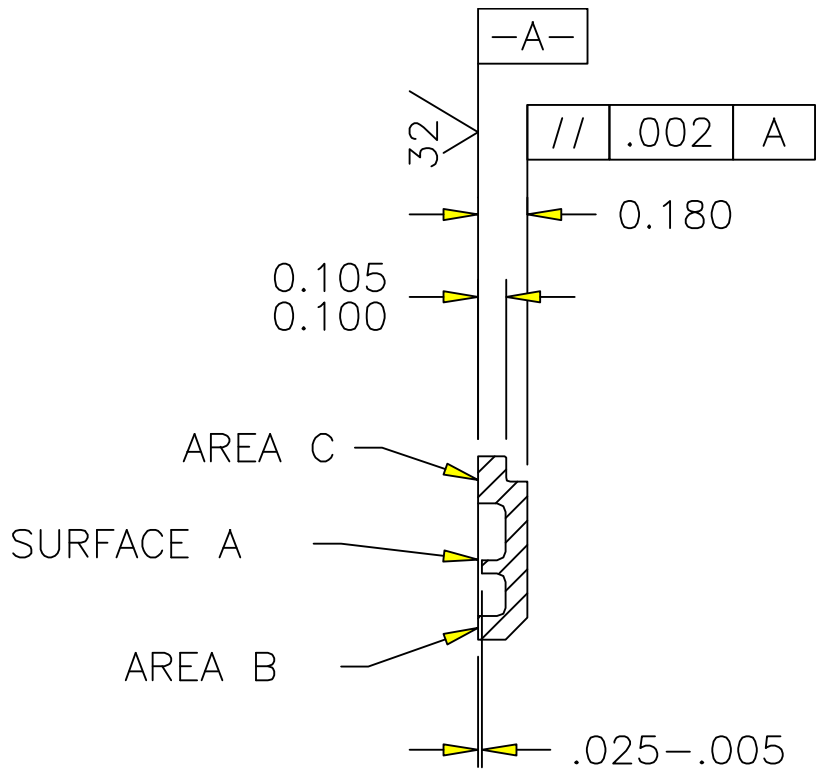
**FIGURE 1**

Condition	Service Limit	Repair Limit	Corrective Action
<b>Crack Indications (FPI*)</b>	Cracks are not acceptable.	No repair.	Replace.
<b>Wear on Surface A (See Figure 1)</b>	Maximum step between Areas B and C (See Figure 1) 0.003 inch.	Maximum metal removal 0.010 inch, Minimum thickness across Area C (See Figure 1)	Repair by plating.
<b>Flatness of Surface A (See Figure 1)</b>	Must be flat within 0.005 inch.		Repair by plating or grinding.

NICKEL PLATE SURFACE A AND AREA B 0.0003-0.0005 MIN THICKNESS  
PER AMS 2404 AND BAKE 750°F ± 10°F (399° ± 12°C ) FOR ½ HOUR.  
OTHER SURFACES ARE OPTIONAL.
