T-024 Inspection Limits and Repair

Hastelloy X Combustion Liner Assembly

Engine Application(s):	250-B17, C20 Series
Subject:	Inspection and Rework procedure for Hastelloy X Combustion Liner Assembly, P/Ns A23056108, E23056108 and E23060429; Overhaul Details for P/Ns A6875628, E6875628, A23007530, E23007530, A23004529, E23004529, E23061212, E23061213 and E23061216.
Compliance:	Any time Combustion Liner Assembly is accessed during repair or overhaul.
Notes:	Replaces Service Letter issued by Superior Turbine on October 17, 1995. Refer to OEM's published data for installation, engine operation and disassembly. OEM or FAA approved Instructions for Continued Airworthiness may be used for inspection, overhaul and repair as an alternate means of compliance with this document.
Revisions:	<p>A Dated: 01/30/97 Updated Format.</p> <p>B Dated: 12/08/97 Updated Format and added Assy & Detail P/Ns E23060429, E23061212, E23061213, E23061216.</p> <p>C Dated: 10/10/02 Added louvers to III-C Thermal Distress.</p> <p>D Dated: 06/11/04 E23056108 was E2056108 in header.</p> <p>E Dated: 09/08/09 Updated EXTEX to TIMKEN.</p> <p>F Dated: 2/02/16 Updated Timken to EXTEX Engineered Products.</p>

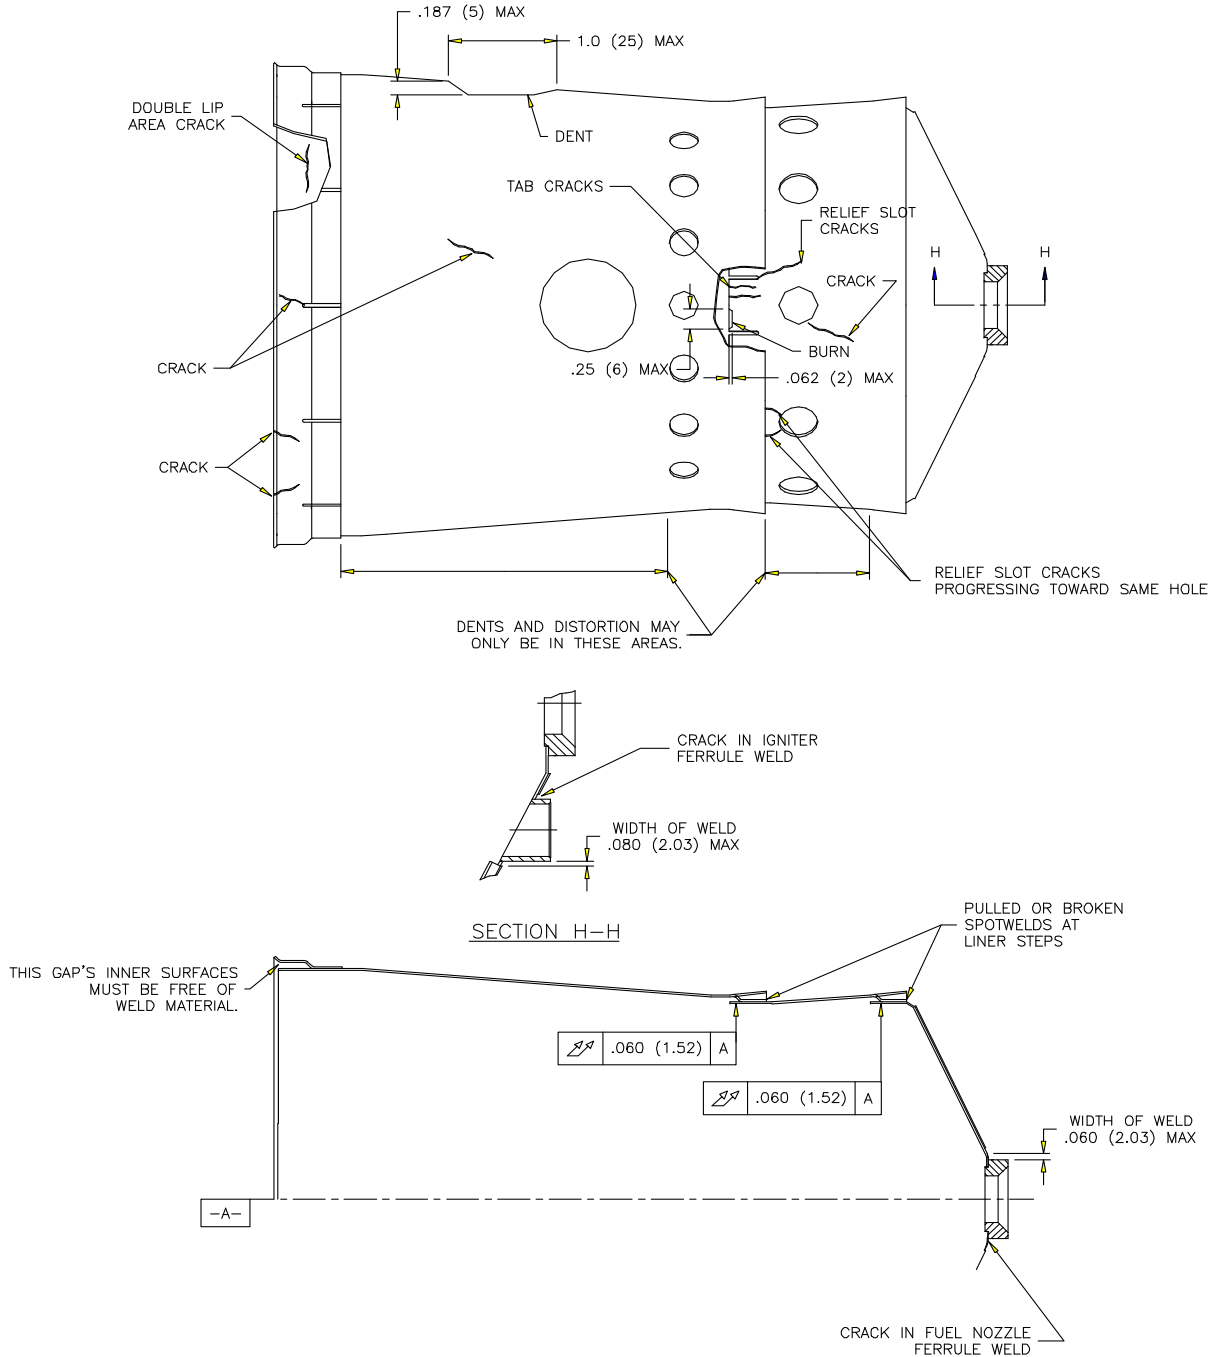
FIGURE 1
Hastelloy X Combustion Liner

A. Cracks (ref. Fig. 1)

Location	Service Limit	Repair Limit	Corrective Action
Cracks on outer wall.	Cracks are not acceptable.		Weld repair *. Crack must be completely welded. Weld material must not obstruct cooling air passage.
Crack in tab end inside liner.	Max. of ¼ inch length and limited to 2 cracks per tab.		Repair or replace.

Location	Service Limit	Repair Limit	Corrective Action
Cracks at two adjacent relief slots progressing toward same hole.	Max. of 1/8 inch length and limited to 2 cracks propagating towards the same hole.		Repair or replace.
Crack in relief slot at combustion liner step.	Max. of 1/8 inch length and limited to 2 cracks per relief slot.		Weld repair *. Grind weld material only if it blocks or restricts airflow.
Crack in double lip area.	Cracks are not acceptable.		Weld repair *. Surfaces between lips must be free of weld material.
Cracks in expansion slots.	Cracks are not acceptable.		Weld repair *. Surfaces between lips must be free of weld material.
Crack in weld attaching igniter or fuel nozzle ferrule.	Cracks are not acceptable.		Weld repair *. Max. width of weld 0.080 inch.

B. Physical Deformations (ref. Fig. 1)

Condition	Service Limit	Repair Limit	Corrective Action
Out of Round	None.	Unable to straighten to concentricity limits.	Straighten and reform by cold-working.
Dents	None.	Unable to straighten to concentricity limits or dent causes thin-out of metal.	Straighten and reform by cold working dents in allowable areas indicated on Fig.1.
Worn or distorted (out of round) igniter ferrule.	Min. of 0.020 inch wall thickness and max. of 0.560 inch ID.		Weld Repair * or replace.
Louvers bent closed.	Maintain 0.060-0.065 inch Uniform opening.		Reposition by bending to proper opening.
Worn or distorted (out of round) fuel nozzle ferrule.	Max. of 0.670 inch ID.		Weld Repair * or replace.

C. Thermal Distress / Erosion (ref. Fig. 1)

Condition	Service Limit	Repair Limit	Corrective Action
Localized high temperature distortion indicated by warping of liner surface.	Max. of 0.187 inch depth over 1 inch diameter and within allowable areas given on Fig.1.		Repair or replace.
Relief Slot burning	Max. of 0.062 inch on rear edge, or, both corners burned max. of 0.250 inch along relief slot.		Repair or replace.
Burned louvers	None		Repair or replace
Roughened igniter ferrule ID	Max. of 0.560 inch ID after polishing.		Weld Repair *.

* Weld with AMS 5798 Hastelloy X weld rod; 0.035-0.062 diameter. Use Argon torch gas flow of 20-40 cfm, Argon Backup of 10-40 cfm, and 20-60 amp current.
