## 2<sup>nd</sup> Stage Turbine Nozzle Assembly

<b>Engine Application(s):</b>	250-C30, C30G, C30G/2, C30L, C30M, C30P, C30R, C30S
<b>Subject:</b>	Inspection and Rework Procedures for the E23032335, E23055438 & E23062029 2 <sup>nd</sup> Stage Turbine Nozzle Assembly.
<b>Compliance:</b>	Any time the Nozzle Assembly is removed for overhaul. Refer to the Table and Figures for Inspection and Rework Procedures.  Table 1: Acceptance and Rework Limits and Procedures Figure 1: Inspection Figure 2: Dimensional Inspection
<b>Notes:</b>	EXTEX P/N E23032335, E23055438 & E23062029 limits the maximum radial movement to 0.003". This amount of movement complies with Allison CEB 72-3188. Refer to OEM's published data for installation, engine operation and disassembly.
<b>Revisions:</b>	N/C Dated: 6/16/97 Initial release. A Dated: 6/28/99 Removed sources. B Dated: 1/29/01 Added P/Ns E23055438 & E23062029. Updated format. C Dated: 12/3/02 Updated format and revised FPI note **. Added "3 SIDES" to Figure 2 weld symbol. D Dated: 3/21/03 Page 5: "BNi-10 or N99622(UNS)" was AMS4777". Page 6: Removed "blaze" and .100" was .01". E Dated: 9/04/09 Updated EXTEX to TIMKEN. F Dated: 2/02/16 Updated Timken to E

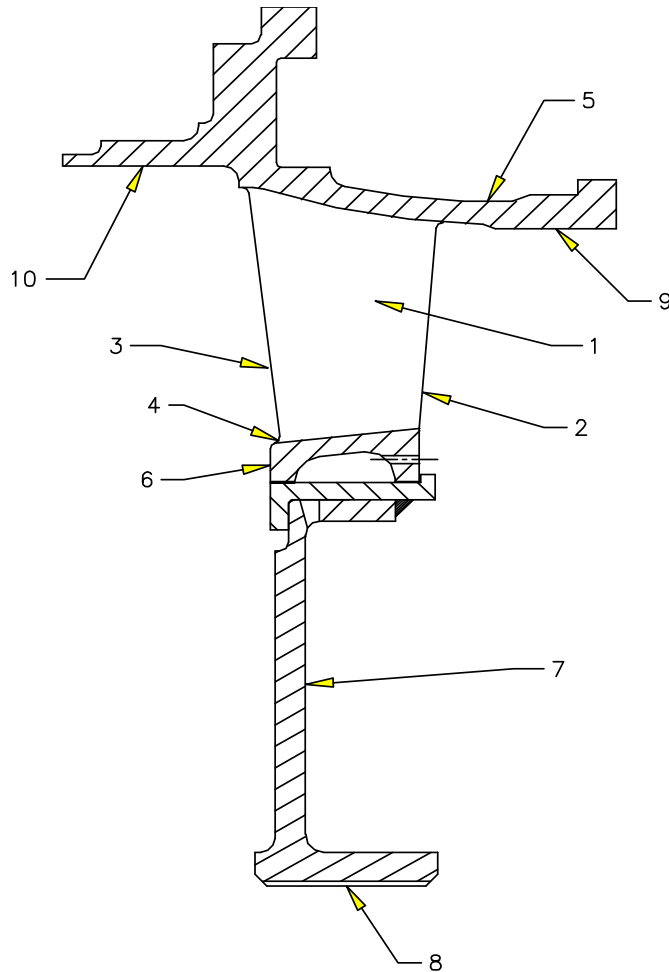
**FIGURE 1**

Key	Location	Description of Condition
1	Vane Airfoil	Cracks
2	Vane Leading Edge	Nicked, Dented
3	Vane Trailing Edge	Nicked, Dented, Warped, Burned
4	Vane Fillet	Cracks
5	Outer Band	Cracks
6	Inner Band	Cracks
7	Diaphragm	Cracks
8	Seal Surface	Wear
9	#1 Blade Tip Path	Wear
10	#2 Blade Tip Path	Wear or Warped

<b>Condition</b>	<b>Service and/or Repair</b>	<b>Corrective Action</b>
<b>Airfoil Crack Indications, Visual and FPI**</b>	Leading Edge: 0.25 inch maximum is acceptable. Trailing Edge: 0.25 inch maximum is acceptable.  Acceptance is contingent upon the following: 1) Two or more cracks cannot lie in the same plane. 2) Multiple cracks are separated by at least 0.25 inch. 3) Two or more cracks do not propagate toward one another.	1) Weld repair. Open void areas. 2) Replace when welding capability exceeded. 3) Furnace braze per approved procedure when crack condition permits. Welding not required when brazing condition exists.  Airfoils may be repaired using FAA/DER approved procedure.
<b>Damaged Airfoils**</b>	Leading Edge: 0.156inch maximum after blending is acceptable provided the EFA is between 6.92 and 7.22. Trailing Edge: 0.156 inch maximum after blending is acceptable provided the EFA is between 6.92 and 7.22.	Install new or serviceable Nozzle or weld repair Vane Ring per approved procedure if Service Limit cannot be met. Blend airfoil to remove damage. <b>*** See Note on Page 5</b> Airfoils may be repaired using FAA/DER approved procedure.

<b>Airfoil Fillet Crack Indications, Visual and FPI*</b>	At Inner Band: 0.25 inch maximum from Leading or Trailing edge. At Outer Band: 0.25 inch maximum from Leading or Trailing edge. <b>NOTE:</b> Length specified is for cracks along the airfoil measured parallel to the adjacent band. Two or more cracks are acceptable provided they do not propagate towards one another.	Install new or serviceable Nozzle if Service Limit cannot be met. Repair using approved braze procedure. Repair using approved weld procedure when braze capability is exceeded. EFA to be between 6.92 and 7.22 after repair. Airfoils may be repaired using FAA/DER approved procedure.
<b>Outer Band Crack Indications, Visual and FPI*</b>	Axial: 0.50 inch maximum into band provided there are not cracks in line on the opposite edge. Circumferential: 0.62 inch maximum completely through wall, provided cracks are between vanes.	Install new or serviceable Nozzle if Service Limit cannot be met. Repair using approved braze procedure when crack condition permits. Weld repair open void areas per approved weld procedure. EFA to be between 6.92 and 7.22 after repair.

<b>Inner Band Crack Indications, Visual and FPI**</b>	Axial: 0.188 inch maximum into band provided there are not cracks in line on the opposite edge. Circumferential: Circumferential cracks are not acceptable.	Repair using approved braze procedure. Repair using approved weld procedure when braze capability is exceeded. EFA to be between 6.92 and 7.22 after repair. Install new or serviceable Nozzle or replace Vane Ring per approved procedure if Service Limit cannot be met.

Condition	Service and/or Repair Limits	Corrective Action
<b>Diaphragm Cracking, Visual and FPI***</b>	Radial cracks not extending into the inner bore are acceptable. Furnace braze repair is permitted on a maximum of 2 cracks, provided they are a minimum of 2 inches apart. Dimples are not permitted.	Install new or serviceable Nozzle or replace Diaphragm assembly per approved procedure if Service Limit cannot be met. Repair using approved braze procedure when crack condition permits. Weld repair open void areas per approved weld procedure. EFA to be between 6.92 and 7.22 after repair.
<b>Inner Seal Bore Wear/ Grooving</b>	Polish to remove burrs and sharp edges. I.D.: 1.833 - 1.835 inch diameter. Depth of Grooves: 0.012 inch maximum. Concentricity: 0.003 inch maximum TIR.	Replate or metallize per approved procedures - <b>See Figure 2.</b> Max. Dia 1.885 inch before brazing or metallizing.
<b>#1 Blade Tip Path</b>	Maximum Inner Diameter of blade tip path: 6.273 inch diameter. Concentricity: 0.005 inch max TIR.	Restore blade path by brazing or metallizing per approved procedures - <b>See Figure 2.</b> Metal removal limits: #1 blade path: 6.281 inch maximum diameter. 0.047 inch minimum localized wall thickness.

<b>Negative Imperfections (Pitting)</b>	Smaller than 0.050 dia and 0.010 deep. Must not be within 0.080 of L.E. or T.E. Limited to one per airfoil and five per part.	Blend to transition smoothly to parent material. Parting line evidence is not acceptable.
<b>Positive Imperfections</b>	Smaller than 0.050 dia and 0.005 tall. Must not be within 0.080 of L.E. or T.E. Limited to one per airfoil and five per part.	Blend to transition smoothly to parent material. Parting line evidence is not acceptable.
<b>#2 Blade Tip Path</b>	Maximum Inner Diameter of blade tip path: 6.697 inch diameter. Concentricity: 0.005 inch max TIR.	Restore blade path by brazing or metallizing per approved procedures - see Figure 2. Metal removal limits: #2 blade path: 6.704 inch maximum diameter. 0.047 inch minimum localized**** wall thickness.

- 1 EXTEX considers airfoil restoration of this part a Major Repair, (as defined in FAR 1,) and should be performed under FAA authorization.
- 2 Airfoil repairs to be performed by an FAA Approved repair facility with Major Repair experience.

- 3 Blending to remove L.E. and/or T.E. damage may effect airflow.
- 4 Recommended airflow to be 6.92 to 7.22 EFA (as determined with a Fleming Flow Rig.)

- 5 FPI indications less than 0.005 inch are acceptable.
- 6 Blend and polish acceptable vane edge damage in a radial direction using a fine file or 320 grit abrasive paper. Optimum blend should produce scallops with a 3:1 width to depth ratio. Maintain a smooth blend with the basic airfoil. Trailing edge radius after blend to be greater than 0.005 inch.

- \* FPI per approved water washable or post-emulsifiable technique. Indications less than 0.005 inch are not interpretable.
- \*\* Weld wire per AMS 5798 or AMS 5675.  
Braze material per BNi-10 or N99622(UNS) procedure per AMS 2675.  
Airfoils may be repaired using FAA/DER approved procedure.

- \*\*\* Blend and polish acceptable vane edge damage in a radial direction using a fine file and 320 grit abrasive paper. Maintain a smooth blend with the basic airfoil. Trailing edge radius after blend to be greater than 0.005 inch.

- \*\*\*\* Localized = Less than 16% (60°) of the Total Circumference of the blade path and no greater than 8% (30°) of the circumference of the blade path in any one area.

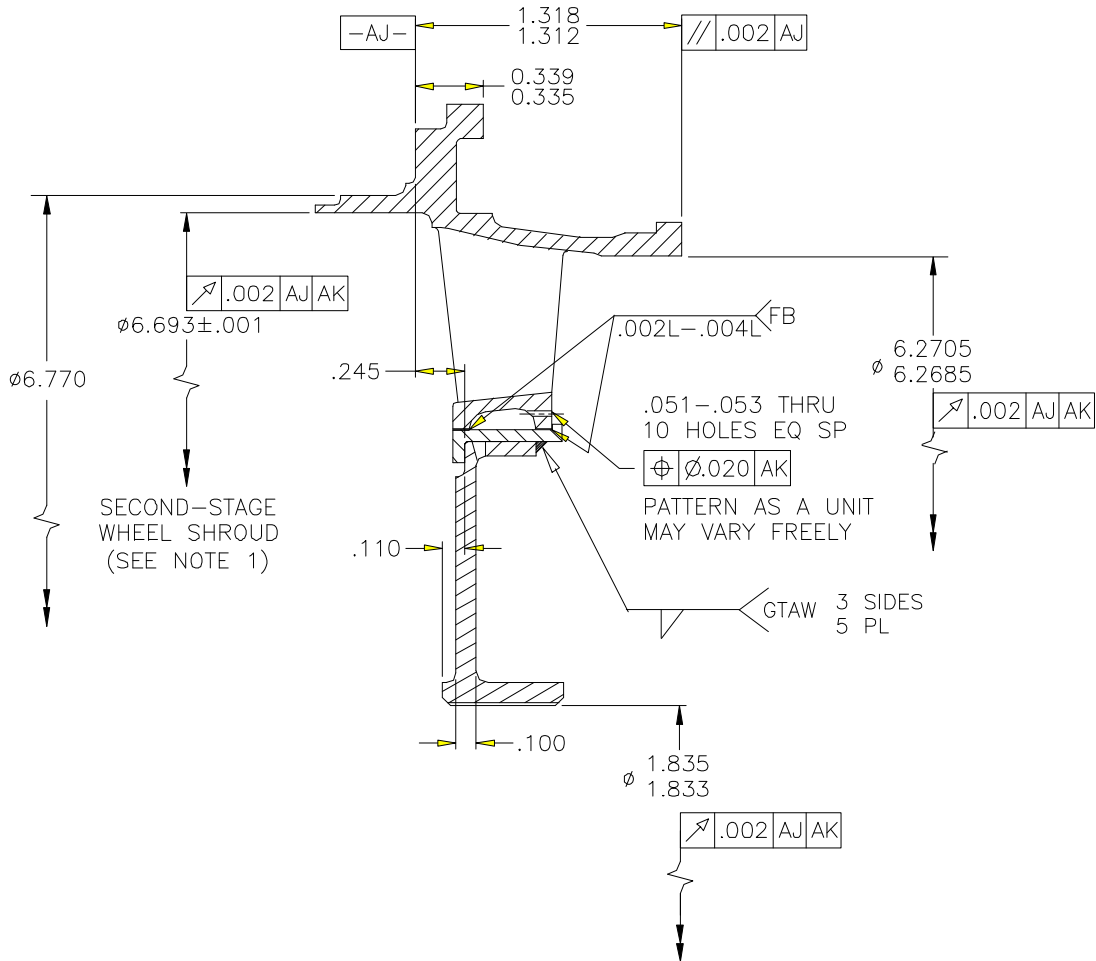
**FIGURE 2**

DATUM -AK- ESTABLISHED BY 8 EQ SP LOCATION TANGS  
DIMENSIONS ARE IN INCHES.

1. FOR DIMENSIONAL RESTORATION OF WHEEL SHROUDS USE AMDRY960, METCO 443, OR METCO 450 REPAIR PROCEDURE.
2. MEASURE DIAPHRAGM WEB THICKNESS. IF WEB THICKNESS IS LESS THAN .100 REPLACE THE DIAPHRAGM.
3. NOMINAL DIMENSION IS 0.115-0.105. DIAPHRAGM BOWING CAN CAUSE THIS DIMENSION TO INCREASE. IF THE SERVICE LIMIT OF 0.135 IS EXCEEDED, REPLACE THE DIAPHRAGM.

Parts meeting the above criteria are eligible for return to service.
