T-066 Inspection Limits and Repair

First Stage Turbine Nozzle

Engine Application(s):	Allison 250-B17, B17B, B17C, B17D, B17E, B17F, B17F/1, B17F/2, 250-C20, C20B, C20C, C20F, C20J, C20R, C20R/1, C20R/2, C20R/4, C20S, C20W.
Compliance:	Any time the nozzle assembly is removed for engine overhaul, it should be inspected to Extex criteria. The inspection will determine if the component is serviceable in its current condition, if it the component is repairable per this instruction or if the component should be replaced.
Notes:	
Revisions:	N/C Dated: 01/11/02 Initial Release. A Dated: 08/27/09 Updated EXTEX to TIMKEN. B Dated: 2/04/16 Updated Timken to EXTEX Engineered Products.

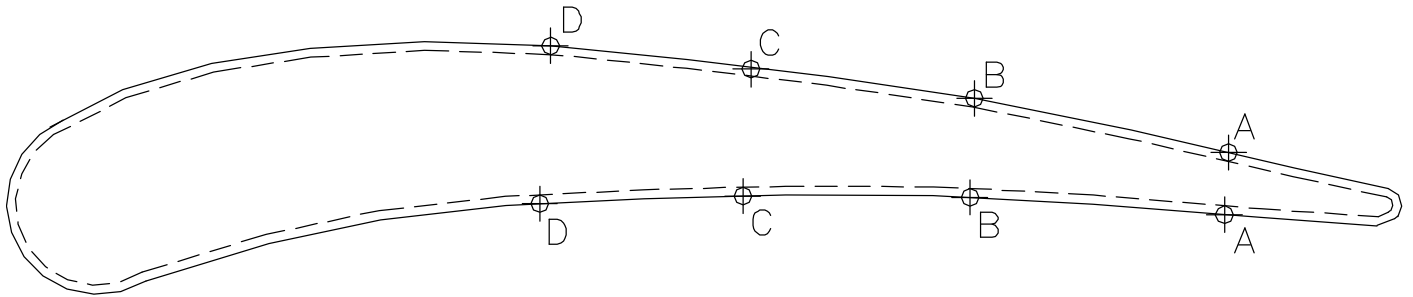
FIGURE 5

TYPICAL AIRFOIL CROSS-SECTION

Location	Distance from Trailing Edge [inches (mm)] - Measured along airfoil surface	Airfoil Minimum Thickness [inches (mm)] - Thickness in fillet radius not measured
A	0.125 (3.17)	0.021 (0.53)
B	0.250 (6.35)	0.034 (0.86)
C	0.375 (9.52)	0.047 (1.19)
D	0.500 (12.70)	0.067 (1.70)

EFA of repaired nozzles must be checked and modified if not within acceptable range. See Sections 6 or 10. Repaired airfoils must meet minimum dimensions shown in Figure 5.
