T-070 Inspection Limits and Repair

First Stage Turbine Nozzle

Engine Application(s):	Allison 250-C40/47
Subject:	Installation, Inspection and Rework Procedures for the E23062061 1 st Stage Turbine Nozzle Assembly.
Compliance:	Any time the nozzle assembly is removed for engine overhaul, it should be inspected to Extex criteria. The inspection will determine if the component is serviceable in its current condition, if it the component is repairable per this instruction or if the component should be replaced.
Revisions:	A Dated: 8/18/05 Added Metal Spray and shim restoration repair B Dated: 8/25/09 Updated EXTEX to TIMKEN C Dated: 2/05/16 Updated Timken to EXTEX Engineered Products

Provide inspection and repair procedure for air-cooled 1st stage nozzle assembly.

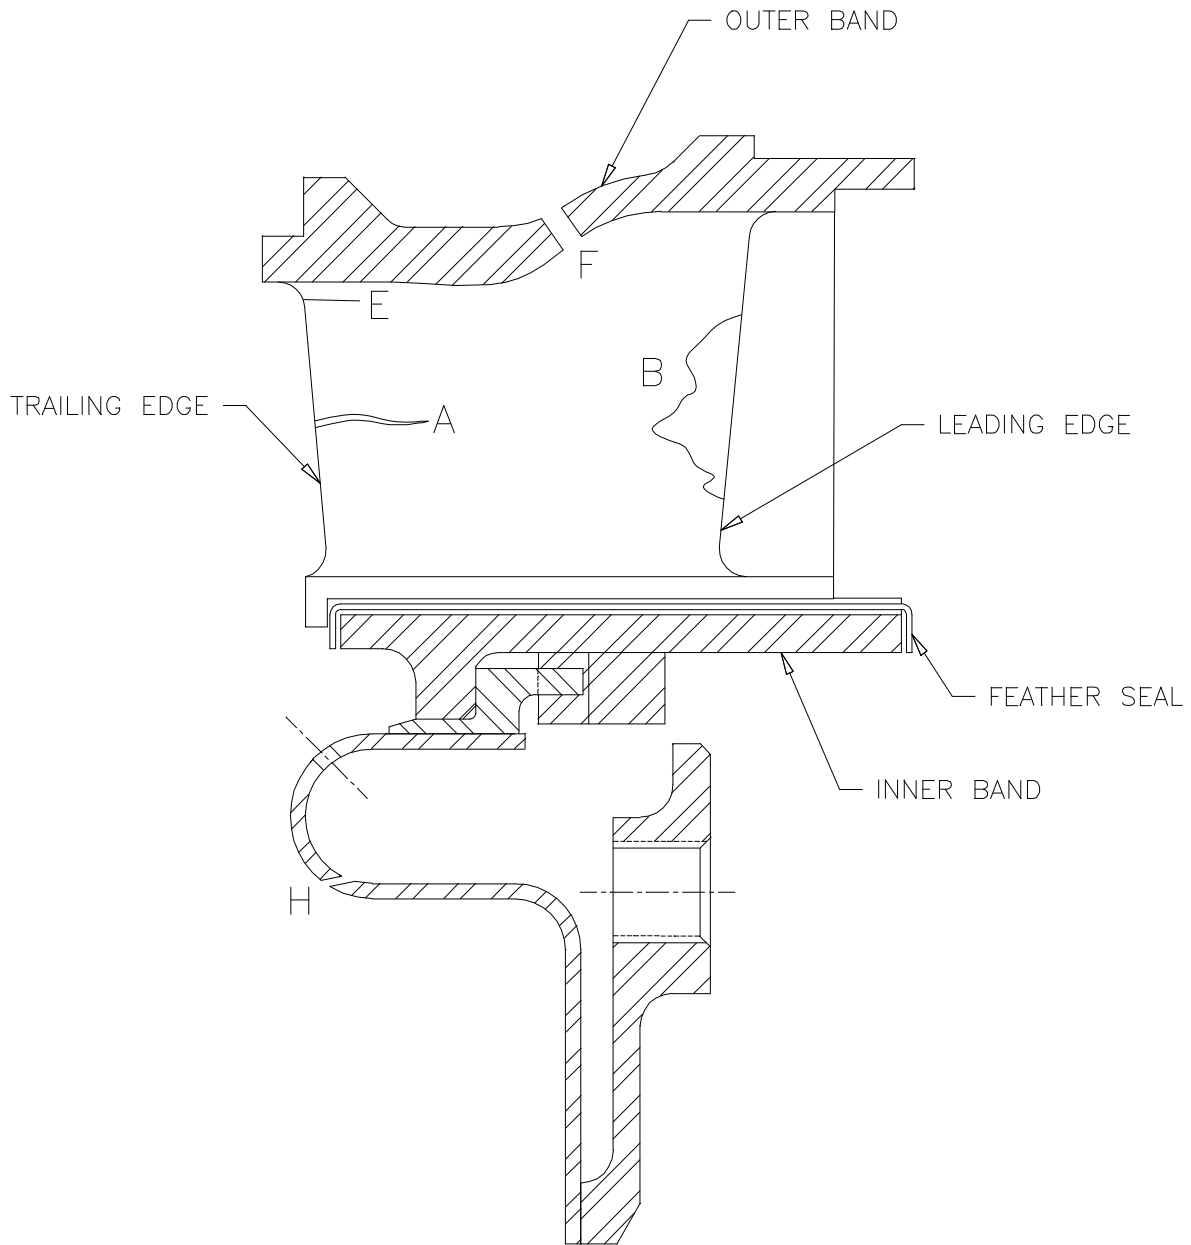
FIGURE 1

Instructions are provided for strip and recoating of gas path surfaces; weld repair of airfoil leading and trailing edges; braze repair of airfoil and fillet cracks; weld or braze repair of inner and outer band cracks, airflow adjustment; and replacement of diaphragm and support plate. Figure 1 depicts key features of the subject nozzles.

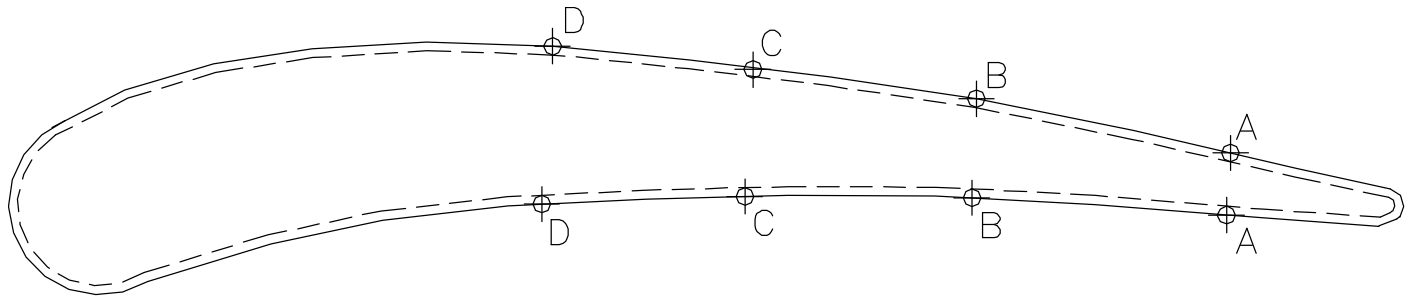
FIGURE 5

Location	Distance from Trailing Edge [inches (mm)] - Measured along airfoil surface	Airfoil Minimum Thickness [inches (mm)] - Thickness in fillet radius not measured
A	0.125 (3.17)	0.021 (0.53)
B	0.250 (6.35)	0.034 (0.86)
C	0.375 (9.52)	0.047 (1.19)
D	0.500 (12.70)	0.067 (1.70)

EFA of repaired nozzles must be checked and modified if not within acceptable range. See Sections 6 or 10. Repaired airfoils must meet minimum dimensions shown in Figure 5.
