T-086 Inspection Limits and Repair

E23068295 Gearshaft, Helical Power Takeoff (PTO)

Engine Application(s):	Rolls Royce (Allison) 250-C Engine Models (refer to Extex PMA supplement for specific engine model applicability)	
Subject:	Helical Power Take Off Gear Inspection Limits and Repair	
Compliance:	On condition or at scheduled engine service event.	
Revisions:	N/C	Dated: 6/13/06 Initial Release.
	A	Dated: 8/12/09 Updated EXTEX to TIMKEN.
	B	Dated: 2/05/16 Updated Timken to EXTEX Engineered Products.

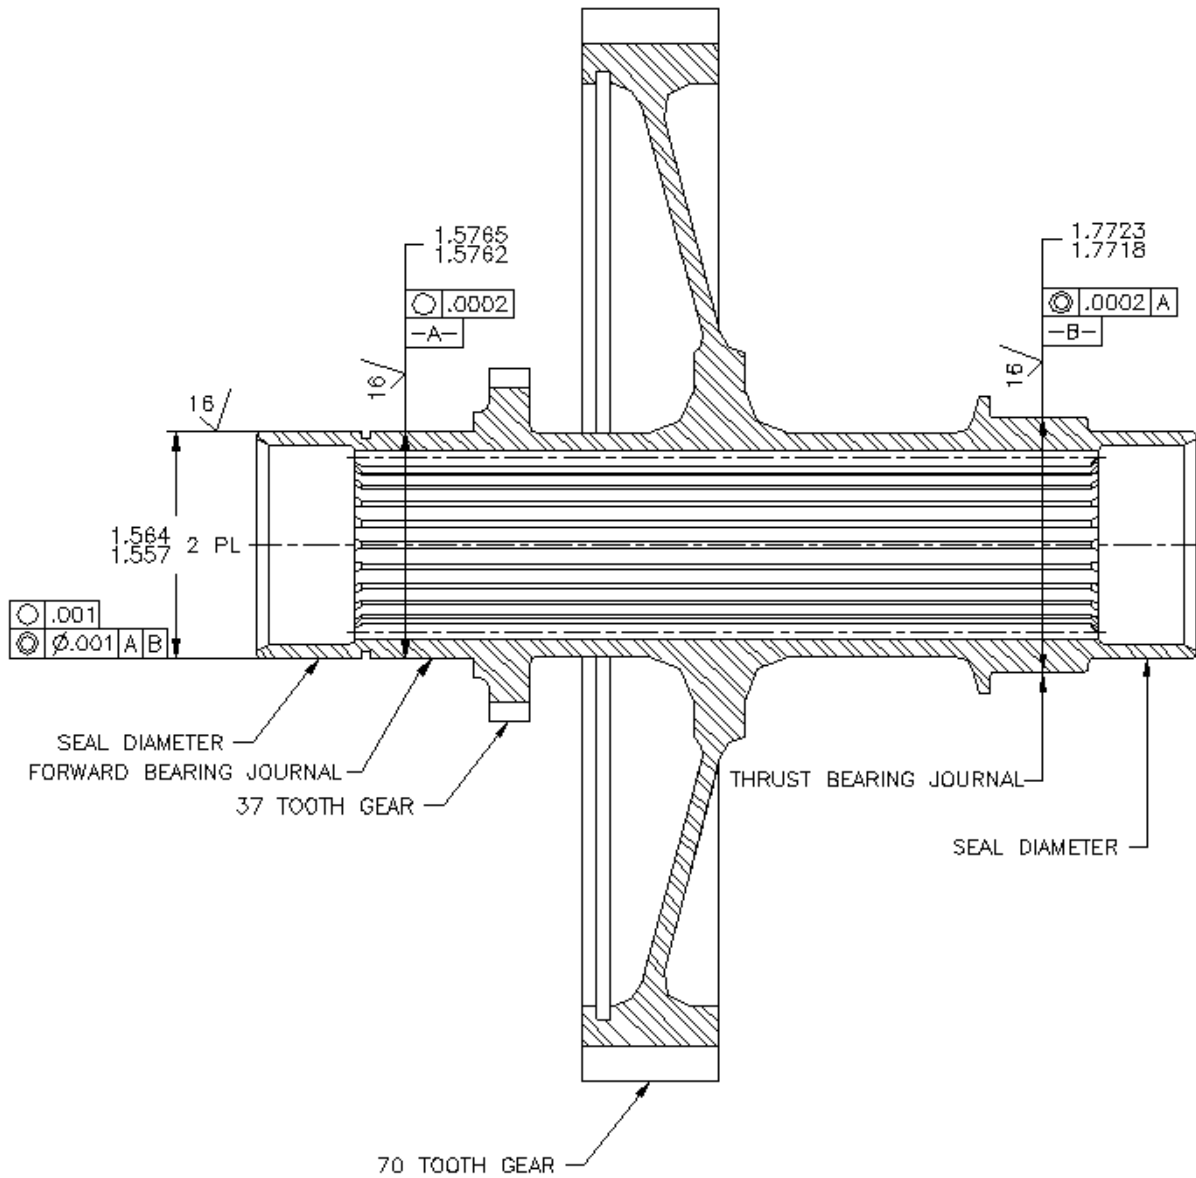
Inspect and rework PTO gear in accordance with Tables 1, 2 and 3 and Figure 1.

1. Grind journal within the concentricity requirements of Figure 1 to remove any roughness or previous plating.
2. MPI the ground journals.
3. Mask areas not to be plated.

4. Electroless nickel plate per AMS 2405. The plating shall be .0005 in (0.013 mm) minimum thickness after final grind.
5. Heat treat at 275 ± 10F (135 ± 6°C) for five hours.
6. After plating, finish grind the plated journals within the concentricity requirements and nominal size limits of Figure 1 unless special sizing is required.
