T-814 ALERT SERVICE BULLETIN

Subject:	Removal of EXTEX Tie Rods and Stub Shaft Inspection
Part Number(s):	E3019371
Engine Application(s):	Pratt and Whitney Canada PT6T-3, -3B, -3BE, -3BF, -3BG, -3D, -3DE, -3DF, -6; PT6A-6, -6A, -6B, -11, -11AG, -15AG, -20, -20A, -20B, -21, -25, -25A, -25C, -27, -28, -34, -34AG, -34B, -35, -36, -110, -112, -114, -114A, -121, -135, -135A
Revision History:	IR - Initial Release.

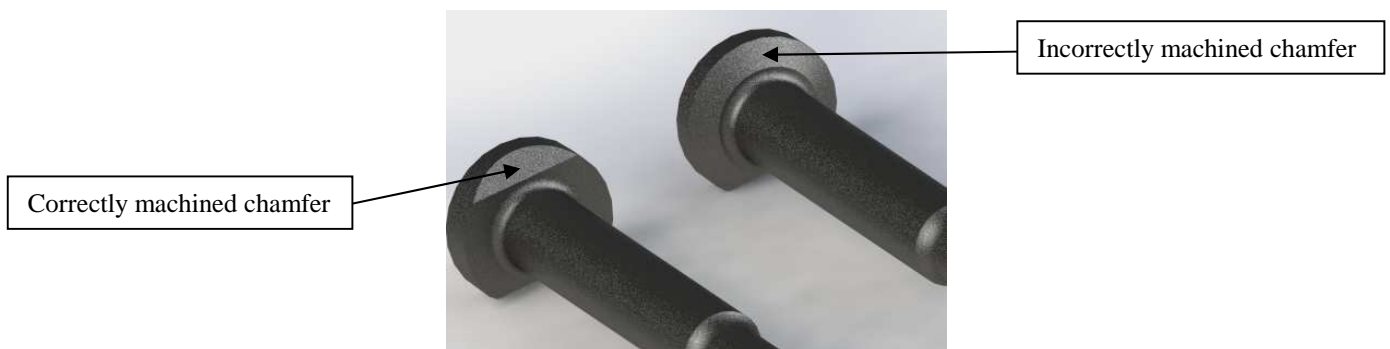
EXTEX has identified a lot of E3019371 Tie Rods in which the under-head chamfer was machined around the perimeter of the "D" head. This creates a stress concentration at the tie rod and stub shaft interface and may reduce the pre load needed to achieve the prescribed stretch. This condition may also cause loss of pre-load of the tie rods and accelerated wear.

EXTEX has contacted all engine shops that installed this lot. For additional assistance please contact EXTEX Customer Support. Lot D64988 can be identified as follows:

Remove the listed applicable tie rods from service in accordance with the applicable TCH (Type Certificate Holder) maintenance manual as soon as possible.

Remove and inspect the stub shaft in accordance with the TCH maintenance manual.

Install FAA-approved tie rods in accordance with the applicable TCH maintenance manual.
