T-027 Inspection Limits and Repair

Turbine Tie Bolt

| Subject: | Inspection and Rework Procedures for the E23008030 Turbine Tie Bolt. |

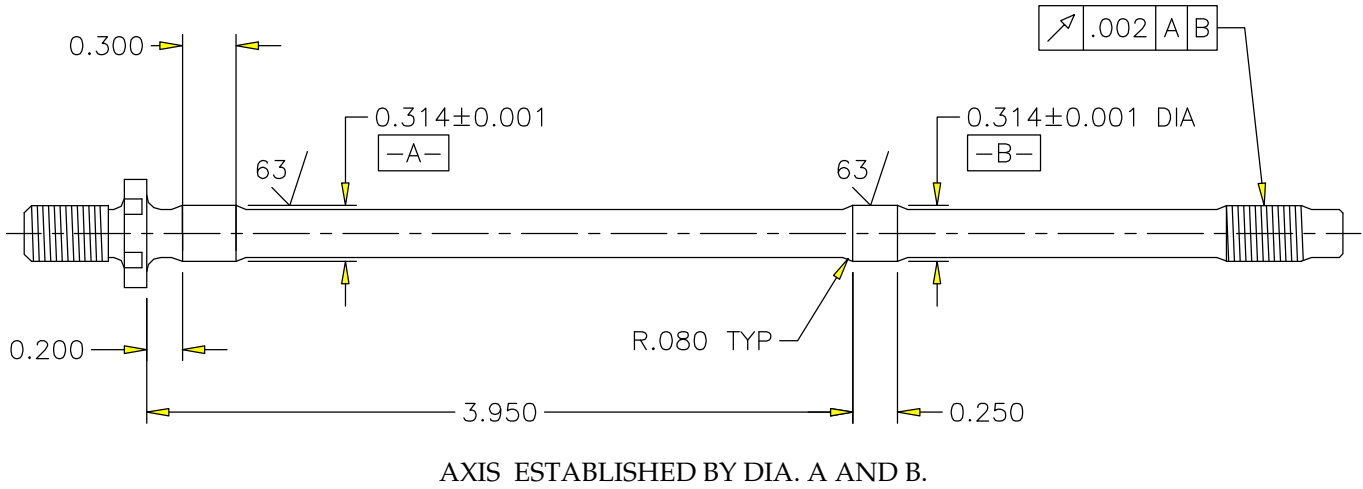
FIGURE 1

| Condition | Service Limit | Repair Limit | Corrective Action |
|--|---|---|--|
| Worn, Fretted or Pitted Mutes | Minimum Mute diameter: 0.3125 inch. Pitting is not acceptable. | Minimum Mute diameter that can be repaired: 0.300 inch. | Replace Tie Bolt when Service Limit is exceeded. OR Plate mute to Figure 1 dimensions per approved procedure. |

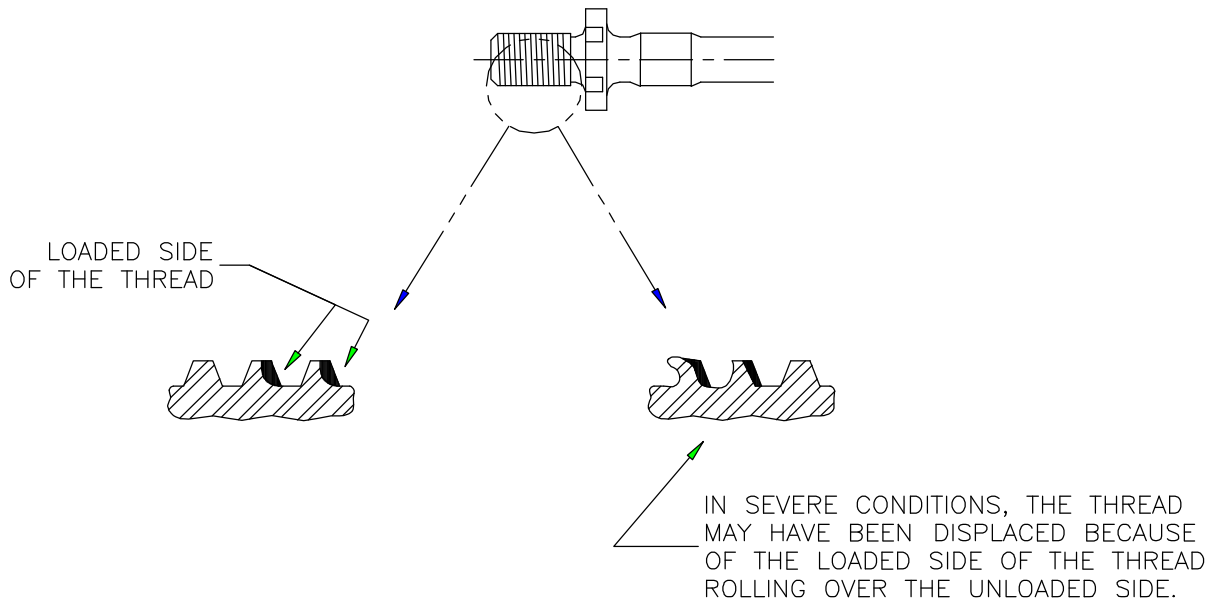
FIGURE 2

| Condition | Service Limit | Repair Limit | Corrective Action |
|--|---|---|--|
| Worn, fretted, or scored threads (Visual with 10X magnification).** | Any sign of thread damage (i.e. wear step, fretting, or scoring) that could cause abnormal drag (resistance to rotation) during nut tightening shall cause rejection of the tie bolt. | No repair. | Replace Tie Bolt. |
