T-066 Inspection Limits and Repair

First Stage Turbine Nozzle

Engine Application(s):	Allison 250-B17, B17B, B17C, B17D, B17E, B17F, B17F/1, B17F/2, 250-C20, C20B, C20C, C20F, C20J, C20R, C20R/1, C20R/2, C20R/4, C20S, C20W.
Compliance:	Any time the nozzle assembly is removed for engine overhaul, it should be inspected to Extex criteria. The inspection will determine if the component is serviceable in its current condition, if it the component is repairable per this instruction or if the component should be replaced.
Notes:	
Revisions:	N/C Dated: 01/11/02 Initial Release. A Dated: 08/27/09 Updated EXTEX to TIMKEN. B Dated: 2/04/16 Updated Timken to EXTEX Engineered Products.

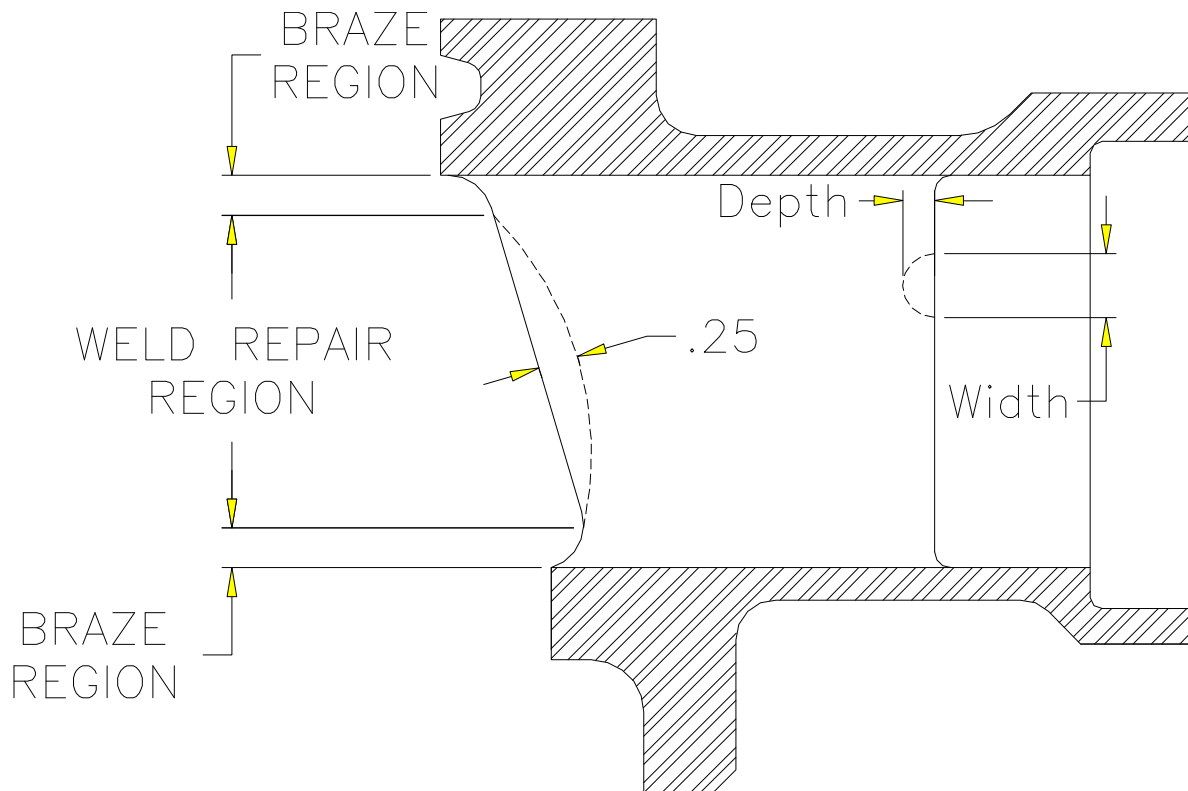
FIGURE 6

3.0 Weld Repair of Airfoils: Welding can be used to replace missing material at airfoil edges or it can be used to repair damage such as cracks. Blend areas to be welded with coated abrasives and/or a carbide burr. Remove all sharp edges, cracks, and surface contamination; such as oxides (from engine service). Material removal should not exceed a depth of .250" from LE or TE of airfoil. Material removal should appear as a gradual arc with a width to depth ratio of 2:1, see Figure 6. Material removal and welding should not be attempted within .050 of fillet between airfoils and inner / outer bands. Fillet cracks should be repaired via furnace braze, see Section 5.

Just prior to welding, all surfaces to be welded should be retouched with a carbide burr. Preheat part to 700°F (371°C) before welding and maintain an interpass temperature of 700°F (371°C). Weld build-up as necessary via Gas Tungsten Arc (GTA) welding, also known as Tungsten Inert Gas (TIG) welding. It is recommended to use .030" to .045" diameter weld filler. Weld filler is Inconel 625, see note below. Minimize heat input to avoid cracking.

Visually inspect welds for gross porosity and/or cracking. Note that weld bead will appear rough and may be mistaken for defects. Questionable areas can be hand finished to verify presence of defects. Restore vane contour, LE radius and TE radius via hand finishing (blending). Use coated abrasives or carbide burrs as necessary.
